HIGHWAY 417 (OTTAWA QUEENSWAY) BRIDGE REPLACEMENT/REHABILITATION AND OPERATIONAL IMPROVEMENTS

DESIGNATED SUBSTANCES SURVEY

ONTARIO MINISTRY OF TRANSPORTATION

PROJECT NO.: G.W.P.4145-10-00
DATE: NOVEMBER 2018

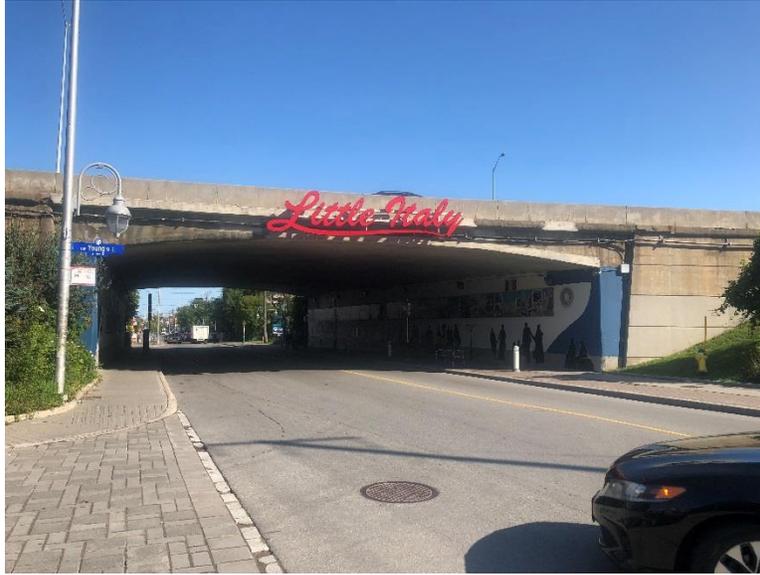
Photograph 1: View of the structure SN-3-055.1 (sidewalk) facing north.

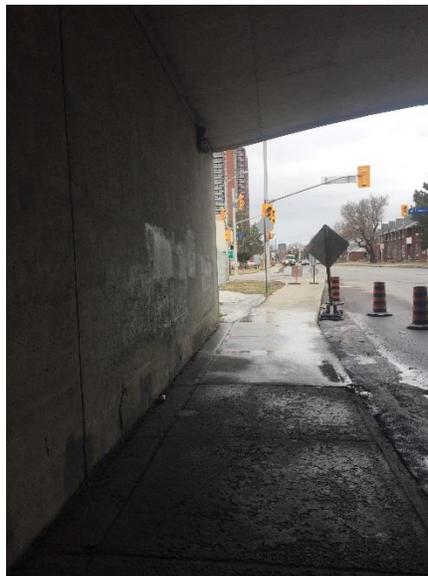
Photograph 2: View of the northwest side of structure SN-3-056.2 (sidewalk) facing north.

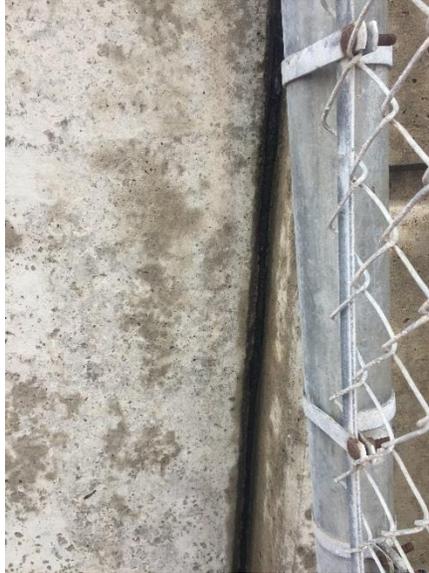
MATERIAL DESCRIPTION	ASSESSMENT	ACTION	PHOTO
Expansion board between concrete sidewalk cracks and along base of abutment walls	<u>Sample ID:</u> SN-3-056-EXP-1A to 1C <u>Concentration:</u> None detected.	None	2
Asphalt Expansion Board	<u>Sample ID:</u> SN-3-056-EXP-2A to 2C <u>Concentration:</u> None detected.	None	3
Concrete, from abutments	<u>Sample ID:</u> SN-3-056-CON-1A to 1C <u>Concentration:</u> None detected.	None	2
Grey paint Applied to the abutment walls	<u>Sample ID:</u> P-1 <u>Concentration:</u> <0.0090%wt	None	2

Photograph 3: Representative photograph of asphalt expansion board located between the expansion joints of structures SN-3-056.1 and SN-3-056.2.

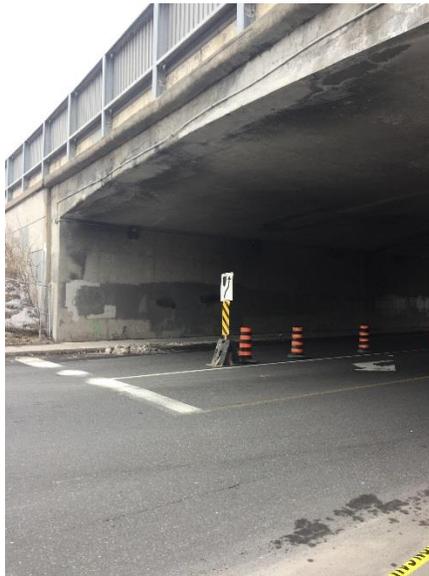
MATERIAL DESCRIPTION	ASSESSMENT	ACTION	PHOTO
Concrete, from west Abutment Stand	<p><u>Sample ID:</u> SN-3-057-CON-1A, CON-1B</p> <p><u>Concentration:</u> None detected.</p>	None	4
Concrete, from east Abutment Stand	<p><u>Sample ID:</u> SN-3-057-CON-1C</p> <p><u>Concentration:</u> None detected.</p>	None	4
Grey paint Applied to the abutment walls	<p><u>Sample ID:</u> P-1</p> <p><u>Concentration:</u> <0.0090%wt</p> <p><u>Condition:</u> Fair to Good</p>	None	4

Photograph 4: View of the northeast side of structure SN-3-57.1 facing southeast.

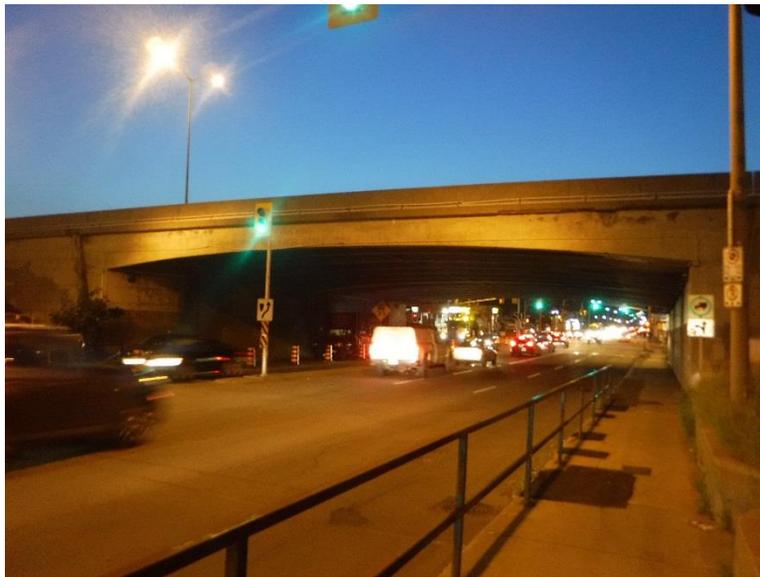
Photograph 5: View of the south side of structure SN-3-60.2 facing north.

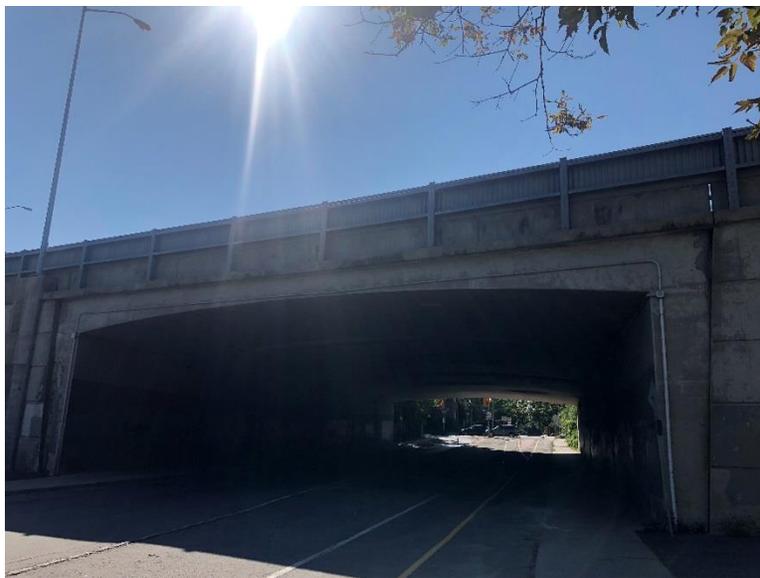
Photograph 6: View of structure SN-3-61.2.

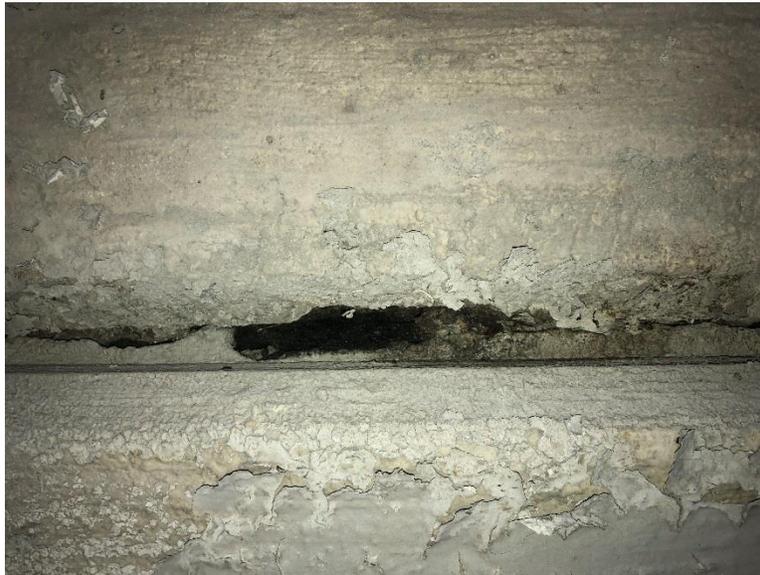
Photograph 7: Representative photograph of asphalt expansion board located between the expansion joints at SN-3-061.1

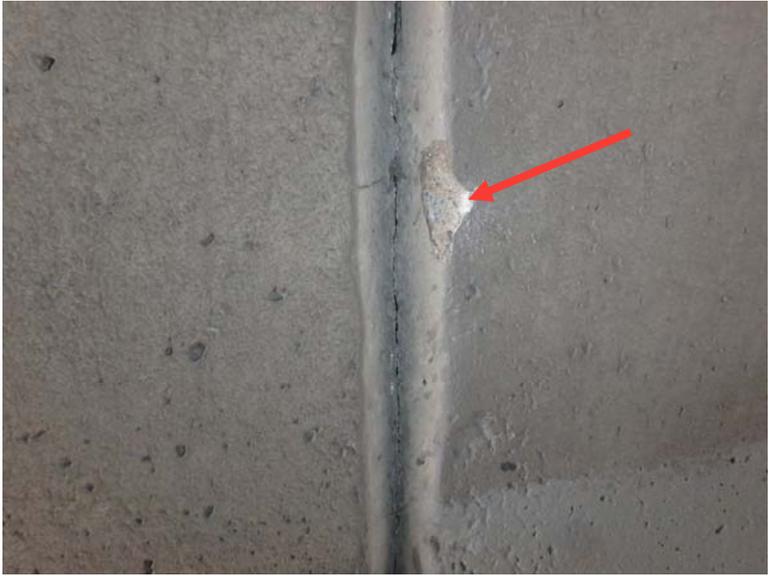
<p><u>4</u></p>	<p><u>Asbestos Containing Textured Coated Wall Covering</u></p> <p>observed on abutment walls throughout the subject area.</p> <p>Sample ID: PRCY-CON-1H</p>

Special precautions should be taken when disturbing any concrete given the presence of silica, lead and potentially arsenic at all bridge structures. Management of the concrete as ACM will be required at the Percy Street Structure. All Designated Substances must be handled in accordance with the appropriate guidelines and regulations. The Ministry of Labour (MOL) has published guidelines for handling and controlling lead and silica in construction and it is recommended that these guidelines be followed when removing and cutting into the concrete. Coring, sawing or breaking up the materials containing silica, lead and potentially arsenic should be completed only with appropriate dust suppression methods, proper respiratory protection and general worker safety precautions as outlined in the MOL Guidance documents and in the Occupational Health and Safety Act.

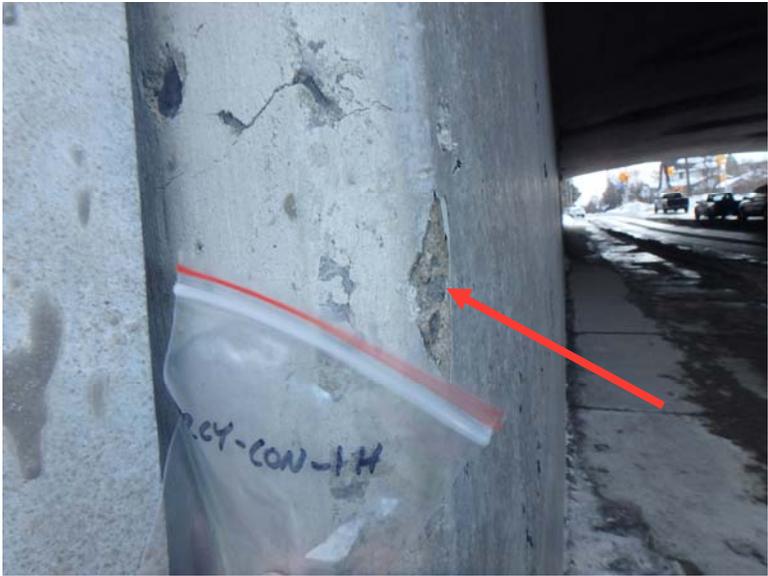
<p>5</p>	<p><u>Asbestos Containing Textured Coated Wall Covering</u></p> <p>observed on abutment walls throughout the subject area.</p> <p>Sample ID: PRCY-CON-1J</p>

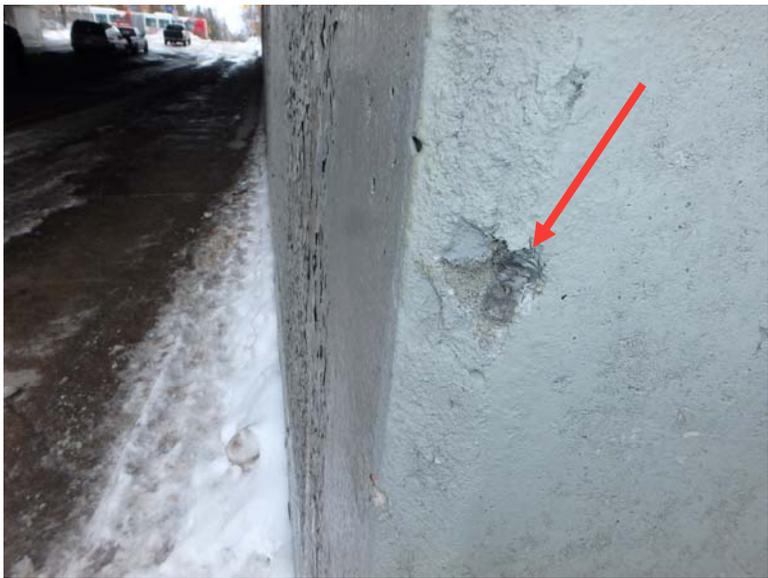
<p>6</p>	<p><u>Asbestos Containing Textured Coated Wall Covering</u></p> <p>observed on abutment walls throughout the subject area.</p> <p>Sample ID: PRCY-CON-2A</p>

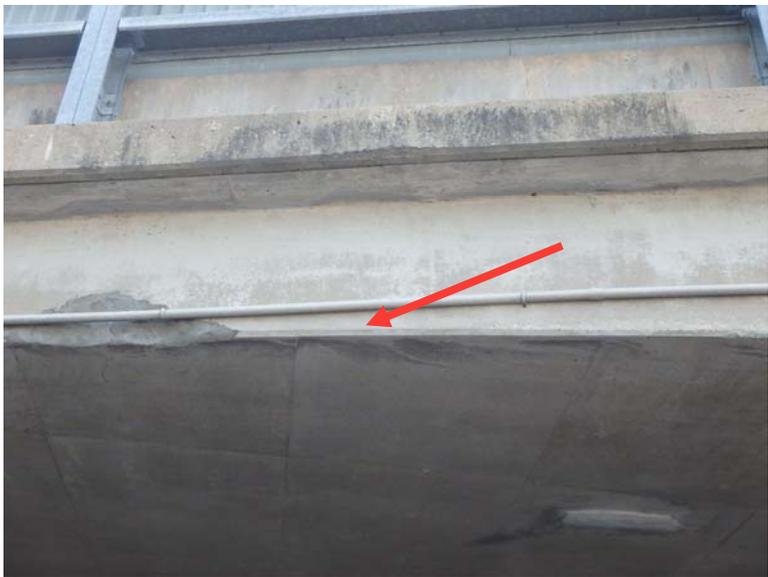
<p>7</p>	<p><u>Asbestos Containing Textured Coated Wall Covering</u></p> <p>observed on abutment walls throughout the subject area.</p> <p>Sample ID: PRCY-CON-2G</p>
