# HIGHWAY 417 BRIDGE REPLACEMENTS / REHABILITATION AND OPERATIONAL IMPROVEMENTS

## GWP 4173-15-00 TREE INVENTORY REPORT

OCTOBER 2017

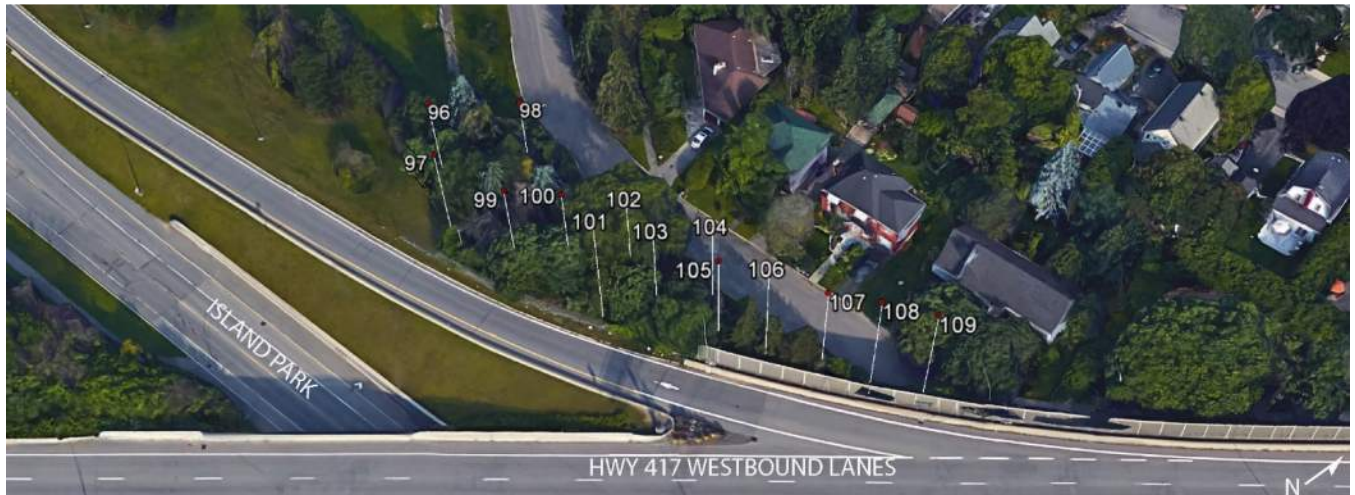
Figure 1: Tree Grouping 1 Mapping - Island Park Crescent Embankment

TREE #	BOTANICAL NAME	COMMON NAME	NO.	DBH (CM)	HEIGHT (M)	CONDITION			REMARKS
						TI	CS	CV	
96	<i>Ulmus</i>	Elm	1	20		G	G	G	Adjacent light pole
97	<i>Acer platanoides</i>	Norway Maple	1	25		G	G	G	-
98	<i>Elaeagnus angustifolia</i>	Russian Olive	1	17		F	F	F	Suppressed canopy growth
99	<i>Acer platanoides</i>	Norway Maple	1	27		G	G	G	-
100	<i>Acer platanoides</i>	Norway Maple	1	25		G	F	F	Suppressed canopy growth
101	<i>Ulmus pumila</i>	Siberian Elm	1	13		G	F	F	Suppressed canopy growth
102	<i>Ulmus pumila</i>	Siberian Elm	1	17		G	F	F	Suppressed canopy growth
103	<i>Ulmus pumila</i>	Siberian Elm	1	32		F	P	P	Suppressed canopy vigour, 70%CV
104	<i>Acer platanoides</i>	Norway Maple	1	31		G	G	G	Suppressed canopy vigour, 70%CV
105	<i>Picea glauca</i>	White Spruce	1	25		G	F	F	Suppressed canopy growth
106	<i>Picea glauca</i>	White Spruce	1	24		G	G	F	Suppressed canopy growth
107	<i>Pinus resinosa</i>	Red Pine	1	31		P	F	P	Suppressed canopy growth, 60% CV

108	<i>Pinus resinosa</i>	Red Pine	1	18		G	F	P	Suppressed canopy growth, 50% CV
109	<i>Ulmus pumila</i>	Siberian Elm	1	20		G	F	F	Suppressed canopy growth, 90% CV

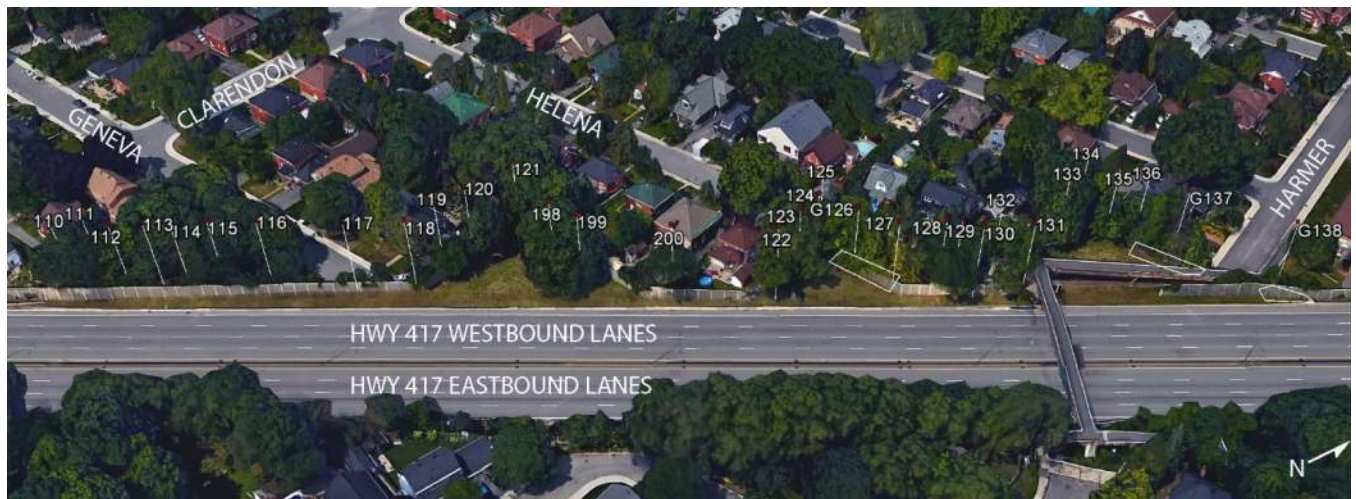
Figure 2: Tree Grouping 2 Mapping – Clarendon Ave. to Harmer Ave.

TREE #	BOTANICAL NAME	COMMON NAME	NO.	DBH (CM)	HEIGHT (M)	CONDITION			REMARKS
						TI	CS	CV	
110	<i>Acer platanoides</i>	Norway Maple	1	50-60		F	G	G	Slight lean, large tree
111	<i>Acer platanoides</i>	Norway Maple	1	30		G	G	F	-
112	<i>Acer platanoides</i>	Norway Maple	1	22		F	F	F	Slight lean, suppressed canopy growth
113	<i>Acer platanoides</i>	Norway Maple	1	17		G	F	F	Suppressed canopy growth
114	<i>Acer platanoides</i>	Norway Maple	1	20		G	F	F	Suppressed canopy growth, 5% dead wood
115	<i>Prunus sp.</i>	Cherry sp.	1	12		F	F	F	Extends over existing noise wall, limb/prune

TREE #	BOTANICAL NAME	COMMON NAME	NO.	DBH (CM)	HEIGHT (M)	CONDITION			REMARKS
						TI	CS	CV	
116	<i>Acer platanoides</i>	Norway Maple	1	24		G	G	F	Extends over existing noise wall, limb/prune
117	<i>Prunus sp.</i>	Cherry sp.	1	10		F	F	F	Suckering at base, immediately adjacent noise wall, remove
118	<i>Acer platanoides</i>	Norway Maple	1	20		P	F	F	Exposed roots, adjacent noise wall, limb/prune
119	<i>Acer platanoides</i>	Norway Maple	1	12-15		F	F	F	Adjacent existing noise wall on private property, limb/prune as required
120	<i>Acer negundo</i>	Manitoba Maple	1	40-60		F	F	F	Multiple stems, adjacent existing noise wall on private property, limb/prune as required
121	<i>Acer platanoides</i>	Norway Maple	1	-		-	G	G	Adjacent existing noise wall on private property, limb/prune as required
198	<i>Acer negundo</i>	Manitoba Maple	1	~20		F	G	G	Weak union, limb/prune
199	<i>Acer negundo</i>	Manitoba Maple	1	~20		F	G	G	Limb/prune as required

TREE #	BOTANICAL NAME	COMMON NAME	NO.	DBH (CM)	HEIGHT (M)	CONDITION			REMARKS
						TI	CS	CV	
134	<i>Acer sp.</i>	Maple species	1	-		-	F	G	Medium canopy tree, adjacent existing noise wall on private property side, limb/prune as required
135	<i>Acer sp.</i>	Maple species	1	-		-	F	F	Suppressed canopy growth, adjacent existing noise wall on private property side, limb/prune as required
136	<i>Acer sp.</i>	Maple species	1	-		-	F	F	Suppressed canopy growth, adjacent existing noise wall on private property side, limb/prune as required
G137	<i>Acer saccharum</i>	Sugar Maple	3	15-20		F	F	F	Tight spacing, suppressed canopy growth, adjacent existing noise wall on private property side, limb/prune as required
G138	<i>Acer negundo</i>	Manitoba Maple	2	12-15		F	F	F	Suppressed canopy growth

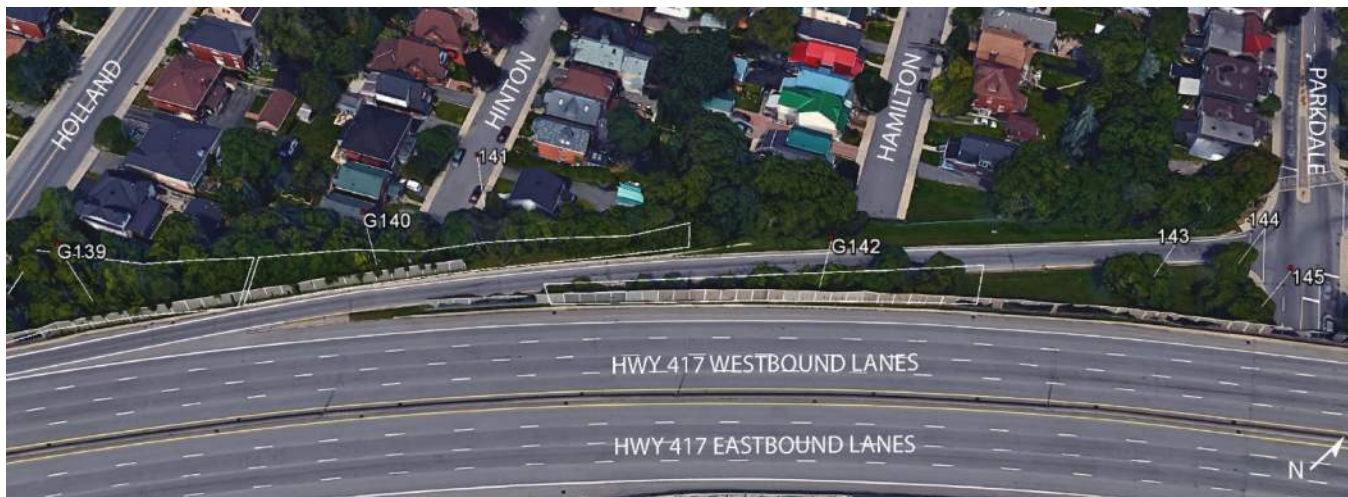
**Figure 3: Tree Grouping 3 Mapping – Holland Ave. to Parkdale Ave.**

TREE #	BOTANICAL NAME	COMMON NAME	NO.	DBH (CM)	HEIGHT (M)	CONDITION			REMARKS
						TI	CS	CV	
G139	<i>Acer negundo</i>	Manitoba Maple	8	15-30		F	F	P	Suppressed canopy growth, growing on steep embankment
G139	<i>Ulmus sp.</i>	Elm species	1	~22		F	P	F	Lean, suppressed canopy growth (70% CV), growing on steep embankment
G139	<i>Acer platanoides</i>	Norway Maple	4	10-20		F	F	G	Growing on steep embankment
G139	<i>Pinus resinosa</i>	Red Pine	1	-		-	-	-	Adjacent existing noise wall
G140	<i>Acer platanoides</i>	Norway Maple	2	~24		G	F	F	Vine in canopy, suppressed canopy growth
G140	<i>Acer negundo</i>	Manitoba Maple	20	15-20		F	F	F	Vine in canopy, suppressed canopy growth
G140	<i>Ulmus pumila</i>	Siberian Elm	1	~15		F	F	F	Vine in canopy, suppressed canopy growth
141	<i>Picea glauca</i>	White Spruce	1	~25		G	G	G	Vine in canopy, on private property
G142	<i>Acer negundo</i>	Manitoba Maple	5	15-20		P	P	P	Growing on steep embankment

G142	<i>Celtis occidentalis</i>	Hackberry	2	~15		G	F	F	-
143	<i>Acer negundo</i>	Manitoba Maple	1	~25		F	F	G	Growing on steep embankment
144	<i>Acer negundo</i>	Manitoba Maple	1	~24		F	F	G	Growing on steep embankment
145	<i>Acer negundo</i>	Manitoba Maple	1	~22		F	F	G	Growing on steep embankment

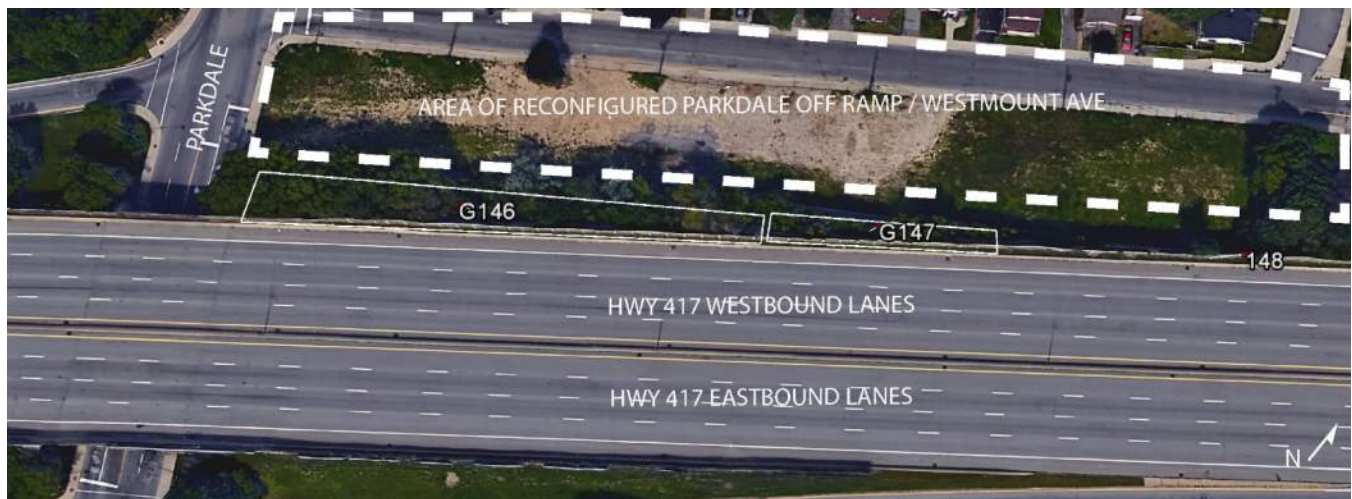
**Figure 4: Tree Grouping 4 Mapping – Parkdale Off-ramp Embankment**

TREE #	BOTANICAL NAME	COMMON NAME	NO.	DBH (CM)	HEIGHT (M)	CONDITION			
						TI	CS	CV	REMARKS
G146	<i>Acer negundo</i>	Manitoba Maple	6	15-20		F	F	F	-
G147	<i>Ulmus pumila</i>	Siberian Elm	2	-		-	-	F	-
G147	<i>Elaeagnus angustifolia</i>	Russian Olive	3	-		-	-	F	-
148	<i>Ulmus pumila</i>	Siberian Elm	1	-		P	P	P	-

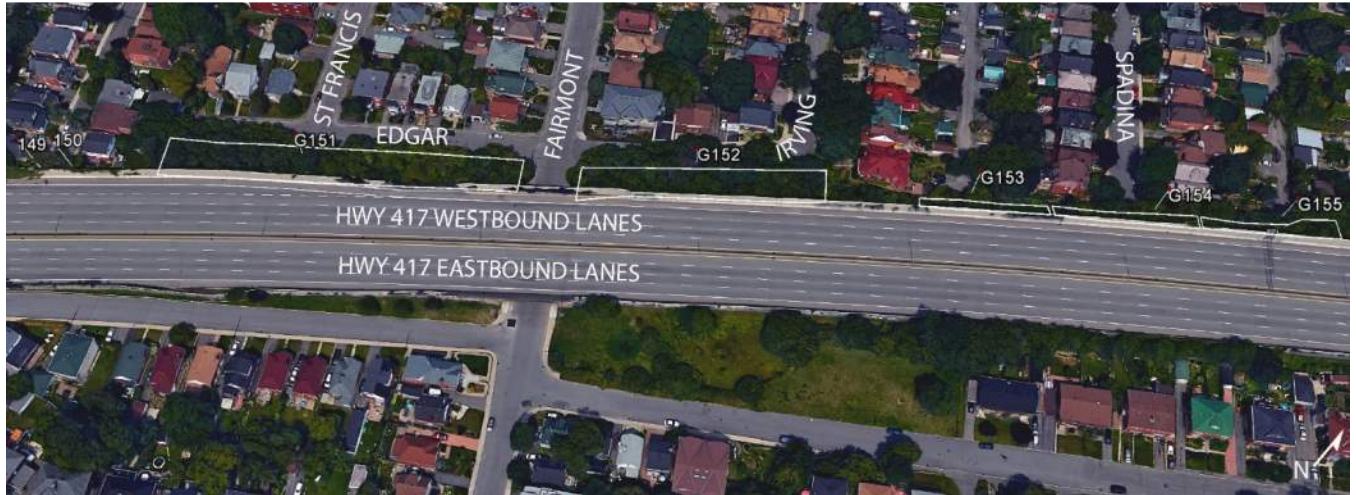
Figure 5: Tree Grouping 5 Mapping – St Francis St. to Bayswater Ave.

TREE #	BOTANICAL NAME	COMMON NAME	NO.	DBH (CM)	HEIGHT (M)	CONDITION			REMARKS
						TI	CS	CV	
149	<i>Ulmus pumila</i>	Siberian Elm	1	23		F	G	G	Weak union
150	<i>Acer negundo</i>	Manitoba Maple	1	19		P	P	P	Suppressed canopy growth (10%CV)
G151	<i>Acer negundo</i>	Manitoba Maple	39	10-30		F	F	F	Vine in canopy
G151	<i>Acer platanoides</i>	Norway Maple	15	15-20		F	F	F	Limb/prune select trees extending over existing noise wall
G151	<i>Juglans nigra</i>	Black Walnut	1	-		G	F	F	Suppressed canopy growth
G151	<i>Quercus macrocarpa</i>	Bur Oak	1	-		G	F	P	Suppressed canopy growth
G152	<i>Acer platanoides</i>	Norway Maple	18	15-25		F	F	F	Suppressed canopy growth
G152	<i>Acer negundo</i>	Manitoba Maple	26	20-35		F	F	F	Suppressed canopy growth, weak unions
G153	<i>Acer negundo</i>	Manitoba Maple	3	15-20		F	F	G	Limb/prune select trees extending over existing noise wall
G153	<i>Acer platanoides</i>	Norway Maple	4	10-20		F	F	G	Limb/prune select trees extending over existing noise wall

G154	<i>Acer negundo</i>	Manitoba Maple	7	10-15		F	F	F	Weak Unions, limb/prune select trees extending over existing noise wall
G154	<i>Acer platanoides</i>	Norway Maple	5	10-15		F	F	F	Limb/prune select trees extending over existing noise wall
G155	<i>Acer negundo</i>	Manitoba Maple	10	10-20		F	F	F	Growing on steep embankment
G155	<i>Acer platanoides</i>	Norway Maple	15	10-20		F	F	F	Growing on steep embankment, limb/prune select trees extending over existing noise wall

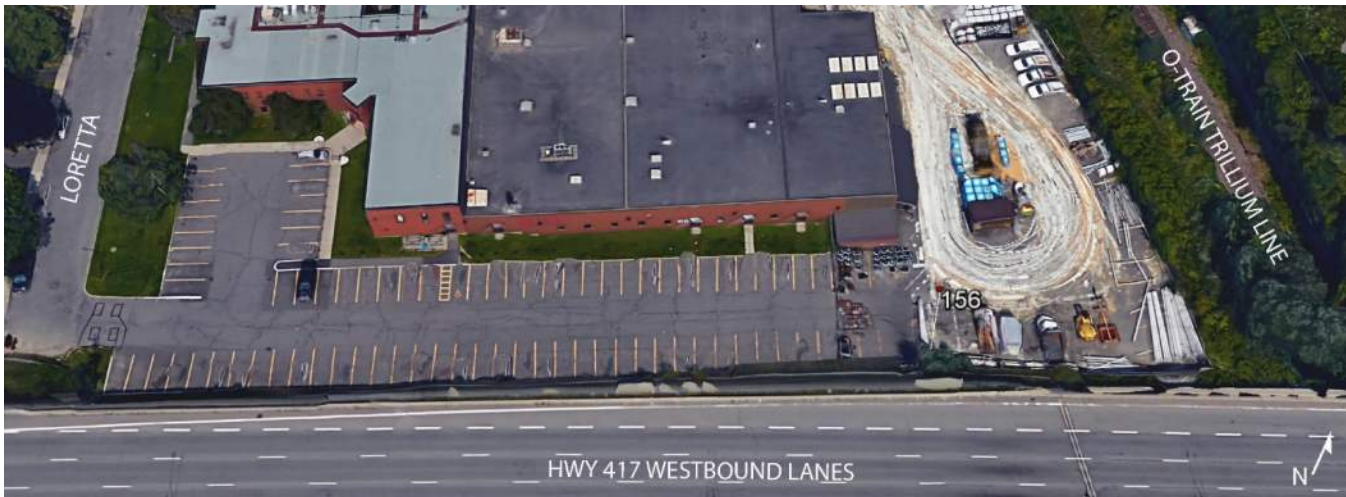
**Figure 6: Tree Grouping 6 Mapping – Retained Embankment at City of Ottawa Traffic Operations Building**

TREE #	BOTANICAL NAME	COMMON NAME	NO.	DBH (CM)	HEIGHT (M)	CONDITION			REMARKS
						TI	CS	CV	
156	<i>Elaeagnus angustifolia</i>	Russian Olive	20	~20		P	F	F	Growing on existing fence line

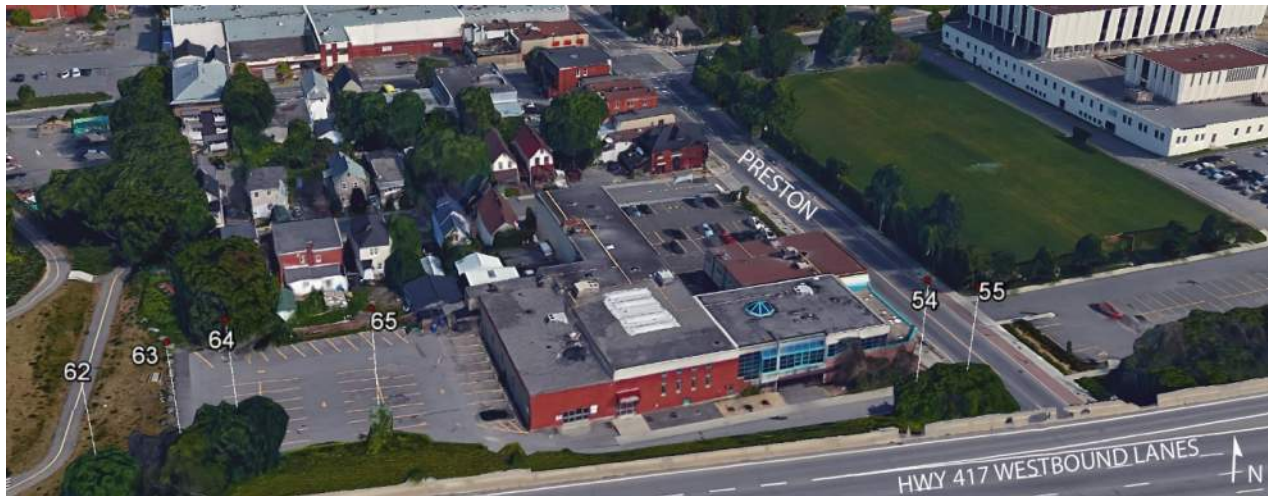
Figure 7: Tree Grouping 7 Mapping – St. Anthony Street at Preston Street

TREE #	BOTANICAL NAME	COMMON NAME	NO.	DBH (CM)	HEIGHT (M)	CONDITION			REMARKS
						TI	CS	CV	
54	<i>Acer negundo</i>	Manitoba Maple	1	35-4	8	P	F	F	Growing at base of retaining and fence.
55	<i>Acer negundo</i>	Manitoba Maple	1	15-20	8	P	F	F	Growing at base of retaining and fence.
62	<i>Ulmus americana</i>	American Elm	1	25-30	15	F	G	F	
63	<i>Celtis occidentalis</i>	Hackberry	1	20-25	10	F	F	F	Multi-stem. Weak union.
64	<i>Celtis occidentalis</i>	Hackberry	4	20-25	10	F	F	F	Multi-stem.
65	<i>Elaeagnus angustifolia</i>	Russian Olive	1	15	6	F	G	F	Vine in canopy.

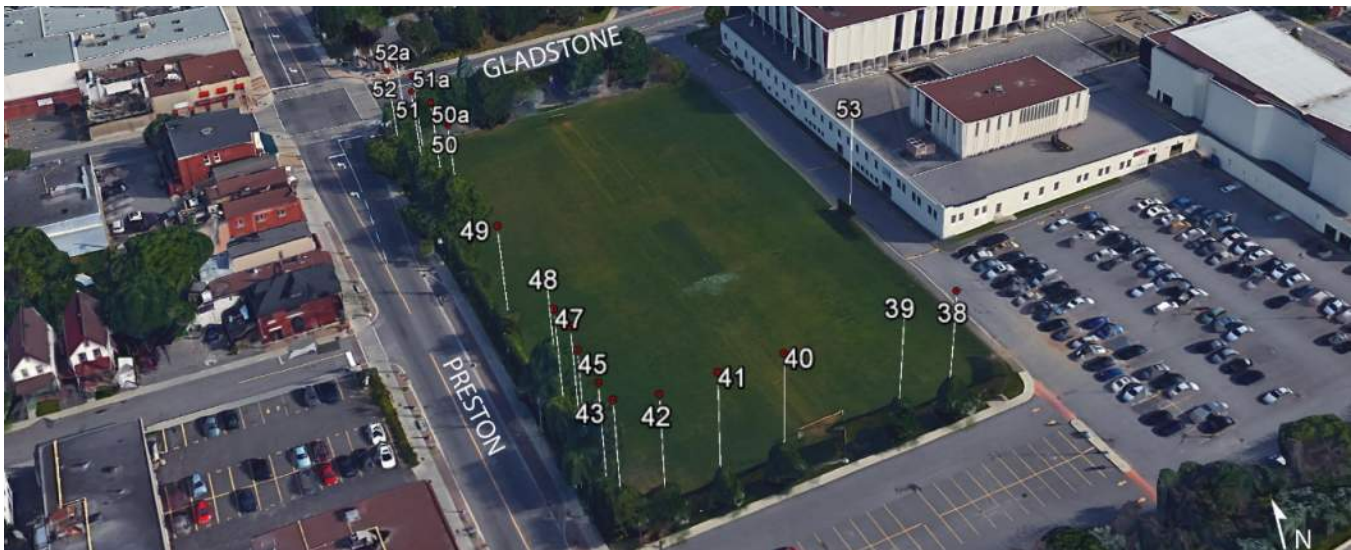
**Figure 8: Tree Grouping 8 Mapping – Soccer Pitch at Preston Street and Gladstone Avenue**

TREE #	BOTANICAL NAME	COMMON NAME	NO.	DBH (CM)	HEIGHT (M)	CONDITION			REMARKS
						TI	CS	CV	
38	<i>Gleditsia triacanthos</i>	Honey Locust	1	15	7	G	G	G	Vine growth in canopy.
39	<i>Gleditsia triacanthos</i>	Honey Locust	1	14	7	G	G	G	Vine growth in canopy.
40	<i>Gleditsia triacanthos</i>	Honey Locust	1	14	7	G	G	G	10 degree lean. Vine growth in canopy.
41	<i>Gleditsia triacanthos</i>	Honey Locust	1	12	7	G	G	F	vine growth in canopy.
42	<i>Gleditsia triacanthos</i>	Honey Locust	1	13	7	G	F	F	10 degree lean. Vine growth in canopy.
43	<i>Acer negundo</i>	Manitoba Maple	1	10-15	10	P	P	F	Growing on fence line. Multi-stem.
44	<i>Acer negundo</i>	Manitoba Maple	1	12	5	P	F	P	Growing on fence line. Suppressed.

TREE #	BOTANICAL NAME	COMMON NAME	NO.	DBH (CM)	HEIGHT (M)	CONDITION			
						TI	CS	CV	REMARKS
45	<i>Ulmus americana</i>	American Elm	1	40-50	15	G	F	F	10% dead wood. On fence line. Pruned under hydro.
46	<i>Acer negundo</i>	Manitoba Maple	1	15-20	10	F	F	P	Vine in canopy.
47	<i>Acer negundo</i>	Manitoba Maple	1	"	5	F	F	P	Vine in canopy. Suppressed.
48	<i>Ulmus americana</i>	American Elm	1	40-50	15	G	F	P	Insect damage on leaves. Pruned under hydro.
49	<i>Acer negundo</i>	Manitoba Maple	1	15-20	5	F	F	F	Pruned under hydro.
50	<i>Acer negundo</i>	Manitoba Maple	1	40-50	8	P	P	F	Growing on fence line. Pruned under hydro.
50a	<i>Acer negundo</i>	Manitoba Maple	4	10	-	P	P	F	
51	<i>Acer negundo</i>	Manitoba Maple	1	30-40	10	P	P	F	Growing on fence line. Pruned under hydro.
51a	<i>Acer negundo</i>	Manitoba Maple	3	10	10	P	P	F	Growing on fence line. Pruned under hydro.
52	<i>Acer negundo</i>	Manitoba Maple	1	30-40	8	F	F	G	Growing on fence line. Pruned under hydro.

52a	<i>Acer negundo</i>	Manitoba Maple	5	10	8	F	F	G	Growing on fence line. Pruned under hydro.
53	<i>Acer negundo</i>	Manitoba Maple	19	8-12	8	F	F	G	Small Manitoba Maple growing on inside of fence line.

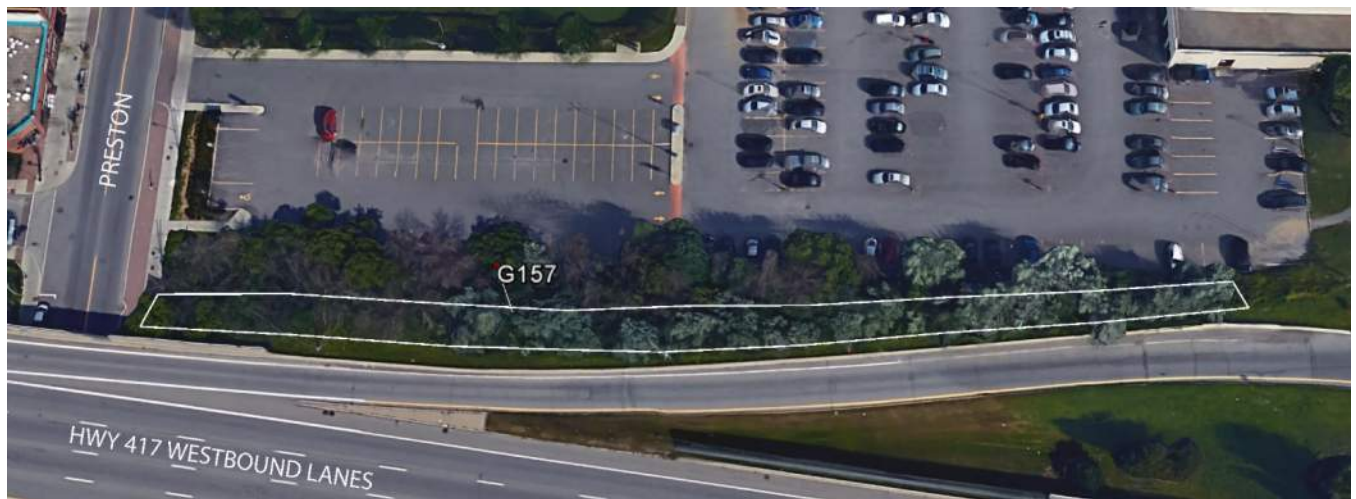
**Figure 9: Tree Grouping 9 Mapping – Rochester St. On-ramp Embankment**

Tree Grouping 9 is north of Highway 417 on an embankment adjacent the Rochester St. on-ramp. Vegetation present is a mix of native and non-native deciduous trees with dense shrub understory. A significant number of dead Ash trees are present in this tree grouping. Thirty-two (32) trees were identified within this grouping. Refer to Table 9 and Figure 9 below for tree mapping and conditions.

TREE #	BOTANICAL NAME	COMMON NAME	NO.	DBH (CM)	HEIGHT (M)	CONDITION			REMARKS
						TI	CS	CV	
G157	<i>Acer negundo</i>	Manitoba Maple	16	10-25		F	F	F	Suppressed canopy growth
G157	<i>Elaeagnus angustifolia</i>	Russian Olive	15	10-20		F	F	F	Suppressed canopy growth
G157	<i>Prunus sp.</i>	Cherry sp.	1	19		F	F	G	Multiple stems (2), weak union

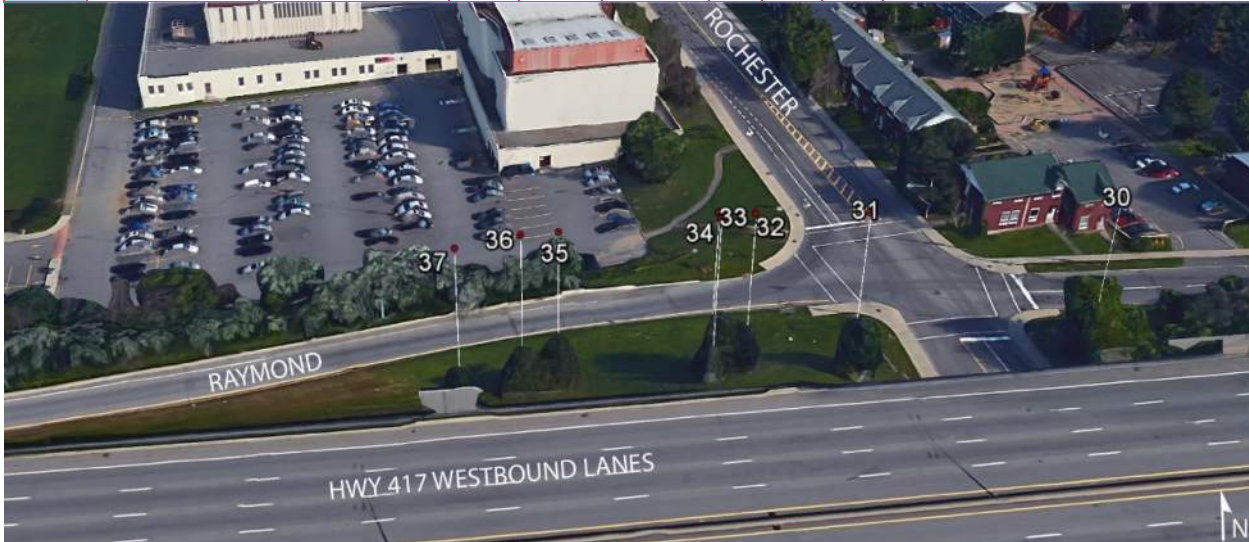
**Figure 10: Tree Grouping 10 Mapping – Rochester Street at 417 westbound on-ramp**

TREE #	BOTANICAL NAME	COMMON NAME	NO.	DBH (CM)	HEIGHT (M)	CONDITION			REMARKS
						TI	CS	CV	
30	<i>Acer negundo</i>	Manitoba Maple	1	25-30	6	P	P	P	Multi-stem. 10 degree lean. Vines in canopy.
31	<i>Acer platanoides</i>	Norway Maple	1	10-15	5	P	P	G	Multi-stem. Poor union.
32	<i>Acer platanoides</i>	Norway Maple	1	15	6	F	F	F	Co-dominant leader.
33	<i>Pinus resinosa</i>	Red Pine	1	35	7	G	F	F	Internal branching. Suppressed canopy growth.
34	<i>Picea pungens</i>	Blue Spruce	1	28	5	G	F	F	Co-dominant leader.
35	<i>Pinus resinosa</i>	Red Pine	1	25	8	G	G	G	-
36	<i>Pinus resinosa</i>	Red Pine	1	25	8	G	G	G	-
37	<i>Pinus resinosa</i>	Red Pine	1	25	8	G	G	G	-

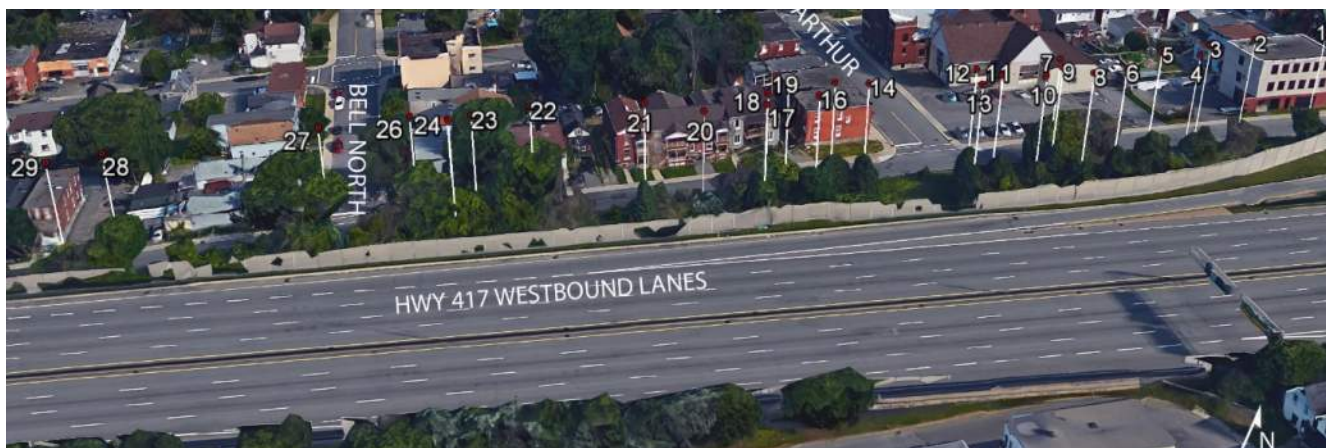
Figure 11: Tree Grouping 11 Mapping - Raymond Street at Arthur Lane and Bell Street

TREE #	BOTANICAL NAME	COMMON NAME	NO.	DBH (CM)	HEIGHT (M)	CONDITION			REMARKS
						TI	CS	CV	
1	<i>Fraxinus americana</i>	White Ash	1	15-20	7	P	P	P	Emerald Ash Borer Damage. Suckering Multi-Stem.
2	<i>Pinus resinosa</i>	Red Pine	1	20-25	5	G	G	G	-
3	<i>Pinus resinosa</i>	Red Pine	1	20-25	5	F	G	G	Slightly deformed trunk.
4	<i>Pinus resinosa</i>	Red Pine	1	20-25	5	G	F	G	Co-dominant leader.
5	<i>Pinus resinosa</i>	Red Pine	1	20-25	5	G	G	G	-
6	<i>Picea glauca</i>	White Spruce	1	15-20	5	G	G	G	-
7	<i>Acer negundo</i>	Manitoba Maple	1	30-45	7	P	P	F	Growing on existing fence line. Multi-stem vigorous.
8	<i>Pinus resinosa</i>	Red Pine	1	20-25	6	G	G	G	-
9	<i>Pinus resinosa</i>	Red Pine	1	20-25	5	F	F	F	Suppressed growth. Crowded by Maple.
10	<i>Pinus resinosa</i>	Red Pine	1	20-25	7	G	G	G	-
11	<i>Pinus resinosa</i>	Red Pine	1	20-25	8	G	G	G	-
12	<i>Pinus resinosa</i>	Red Pine	1	20-25	7	P	F	G	Weak vigor. Co-dominant leader. Internal branching

TREE #	BOTANICAL NAME	COMMON NAME	NO.	DBH (CM)	HEIGHT (M)	CONDITION			REMARKS
						TI	CS	CV	
16	<i>Ulmus americana</i>	American Elm	1	20-25	8	G	F	F	Suppressed growth. Growing on existing noise wall alignment.
17	<i>Ulmus americana</i>	American Elm	1	15-20	8	G	G	G	-
18	<i>Acer negundo</i>	Manitoba Maple	1	15-20	6	P	F	F	Multi-stem. Weak union.
19	<i>Acer negundo</i>	Manitoba Maple	1	20-25	7	P	F	F	Multi-stem. Weak union.
20	<i>Elaeagnus angustifolia</i>	Russian Olive	1	15-20	7	F	F	F	Growing on existing noise wall alignment.
21	<i>Picea glauca</i>	White Spruce	1	25-30	12	G	G	G	-
22	<i>Ulmus americana</i>	American Elm	1	40-50	16	G	F	F	5% dead wood. Large canopy tree.
23	<i>Acer negundo</i>	Manitoba Maple	1	20-30	7	P	P	P	Mutli-stem. Poor union. Large canopy tree.
24	<i>Acer negundo</i>	Manitoba Maple	1	20-25	6	P	P	P	Mutli-stem. Poor union. Large canopy tree. Straight
25	<i>Acer negundo</i>	Manitoba Maple	1	20-25	10	P	P	P	Mutli-stem. Poor union. Large canopy tree. 20 degree lean.

26	<i>Ulmus americana</i>	American Elm	1	30-35	16	F	F	F	10% dead wood. 5 degree lean.
27	<i>Ulmus americana</i>	American Elm	1	25-30	15	F	F	F	10% dead wood.
28	<i>Celtis occidentalis</i>	Hackberry	1	15-20	7	F	F	F	Refer to sample 1. Multi-stem. 5 degree lean.
29	<i>Acer negundo</i>	Manitoba Maple	1	15-20	5	P	P	P	70% dead wood. Vine covered.

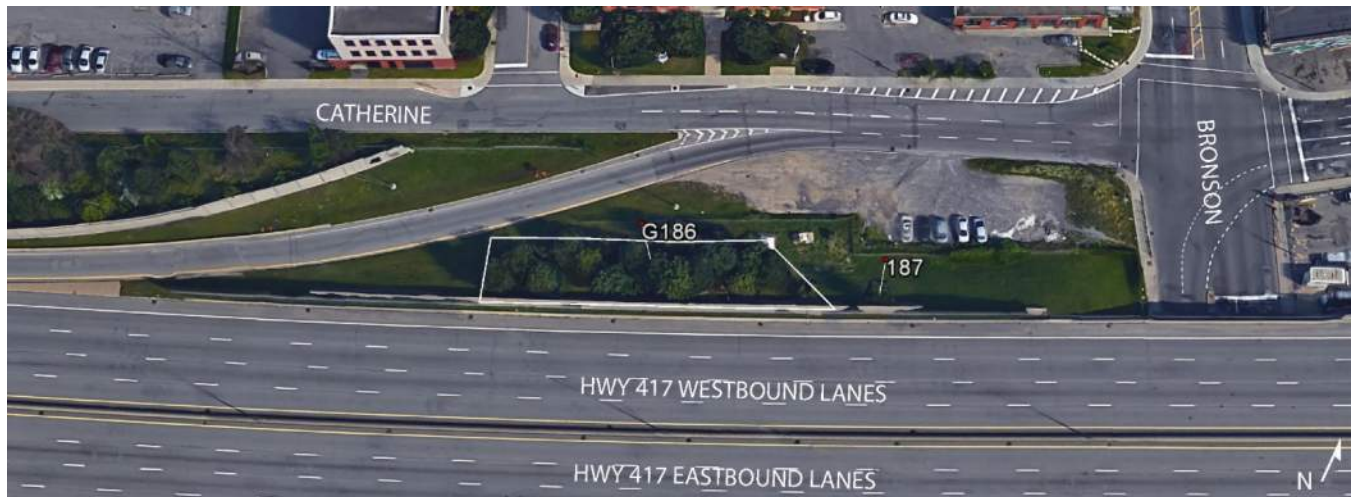
**Figure 12: Tree Grouping 12 Mapping – Embankment at Catherine St. and Bronson Ave.**

TREE #	BOTANICAL NAME	COMMON NAME	NO.	DBH (CM)	HEIGHT (M)	CONDITION			REMARKS
						TI	CS	CV	
G186	<i>Pinus resinosa</i>	Red Pine	9	15-22		G	G	F	-
G186	<i>Acer platanoides</i>	Norway Maple	7	10-20		F	F	F	Multiple stems, suppressed canopy growth
187	<i>Acer platanoides</i>	Norway Maple	1	~14		F	F	G	Multiple stems

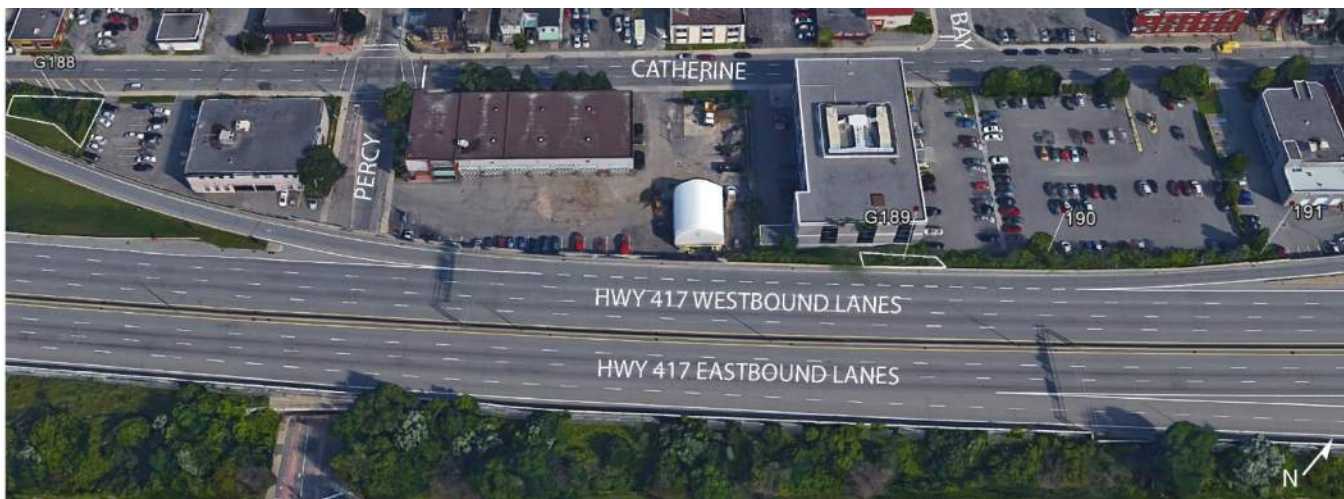
**Figure 13: Tree Grouping 13 Mapping – Embankment at Lyon St. On-ramp and Bronson Ave. Off-ramp**

TREE #	BOTANICAL NAME	COMMON NAME	NO.	DBH (CM)	HEIGHT (M)	CONDITION			REMARKS
						TI	CS	CV	
G188	<i>Acer platanoides</i>	Norway Maple	2	12		P	F	F	Tight spacing, suppressed canopy growth
G188	<i>Acer negundo</i>	Manitoba Maple	10	10-12		P	F	F	Tight spacing, suppressed canopy growth
G189	<i>Ulmus pumila</i>	Siberian Elm	1	~12		F	F	F	Growing on embankment between crib wall + existing noise wall
G189	<i>Acer negundo</i>	Manitoba Maple	3	10-12		F	F	F	Growing on embankment between crib wall + existing noise wall
190	<i>Acer negundo</i>	Manitoba Maple	1	~11		P	F	P	Growing on embankment between crib wall + existing noise wall
191	<i>Ulmus pumila</i>	Siberian Elm	1	14		P	F	F	Growing on existing fence line

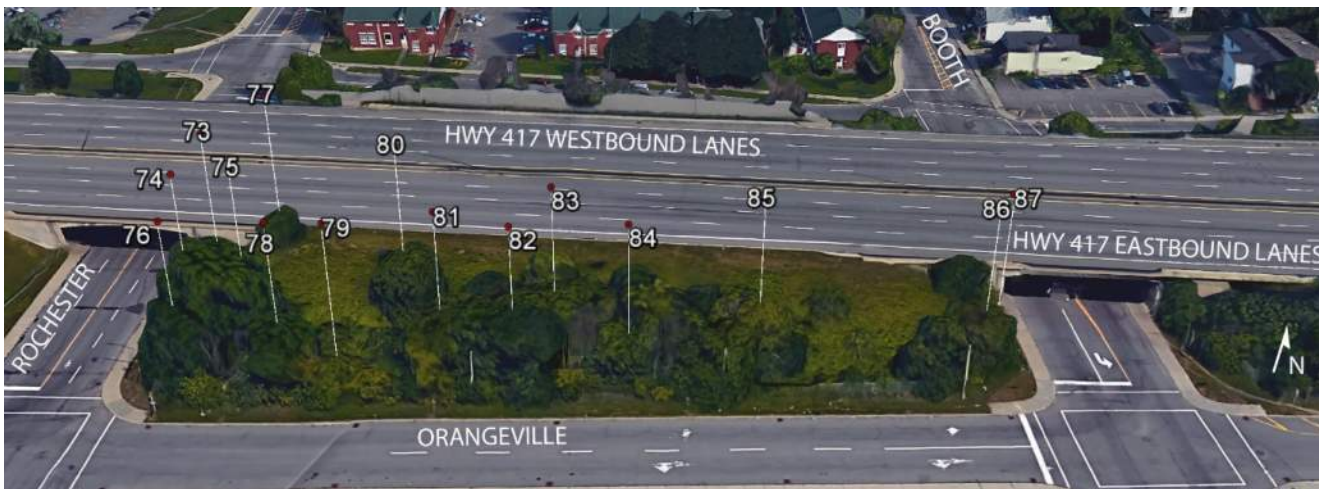
**Figure 18: Tree Grouping 18 Mapping – Orangeville Street between Rochester Street and Booth Street**

TREE #	BOTANICAL NAME	COMMON NAME	NO.	DBH (CM)	HEIGHT (M)	CONDITION			REMARKS
						TI	CS	CV	
77	<i>Ulmus americana</i>	American Elm	1	10-15	5	P	P	P	Multi-stem. Adjacent highway. Suppressed growth.
78	<i>Ulmus americana</i>	American Elm	1	15-20	12	F	F	G	Multi-stem.
79	<i>Acer negundo</i>	Manitoba Maple	1	15	5	P	P	P	Growing on fence line.
80	<i>Acer negundo</i>	Manitoba Maple	1	15-20	10	F	F	F	Suppressed growth. 15% deadwood.
81	<i>Acer negundo</i>	Manitoba Maple	1	20-25	10	F	F	F	Multi-stem.
82	<i>Celtis occidentalis</i>	Hackberry	1	15-20	8	F	F	F	Multi-stem.
83	<i>Acer negundo</i>	Manitoba Maple	8	10-25	8	F	F	F	Grouping.
84	<i>Acer negundo</i>	Manitoba Maple	1	15-25	8	F	F	F	-
85	<i>Prunus sp.</i>	Cherry sp.	1	12	6	F	F	G	Multi-stem.
86	<i>Acer platanoides</i>	Norway Maple	1	20	-	F	P	F	Multi-stem. Grouping on fence. Suckering.
87	<i>Acer negundo</i>	Manitoba Maple	1	12	-	P	P	P	Multi-stem. Suppressed canopy. Suckering.

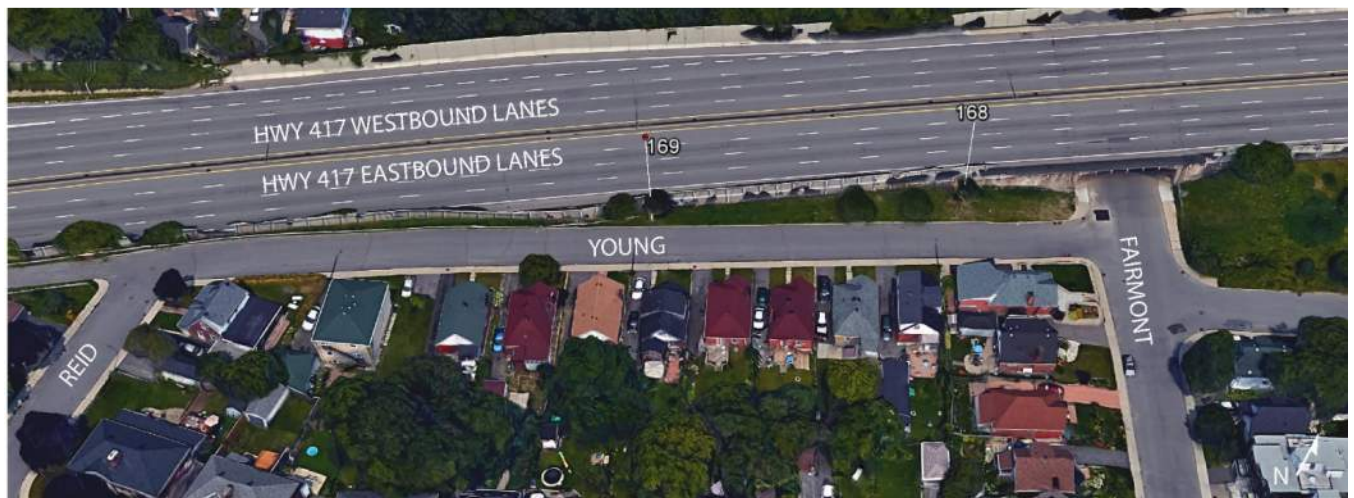
**Figure 23: Tree Grouping 23 Mapping – Embankment on Young St.: Fairmont Ave. to Reid Ave.**

TREE #	BOTANICAL NAME	COMMON NAME	NO.	DBH (CM)	HEIGHT (M)	CONDITION			REMARKS
						TI	CS	CV	
168	<i>Acer platanoides</i>	Norway Maple	1	22		P	F	F	Severe trunk damage
169	<i>Acer platanoides</i>	Norway Maple	1	20		F	P	P	Defoliated on highway-side of tree
