# HIGHWAY 417 BRIDGE REPLACEMENTS / REHABILITATION AND OPERATIONAL IMPROVEMENTS

## GWP 4173-15-00 TREE INVENTORY REPORT

OCTOBER 2017

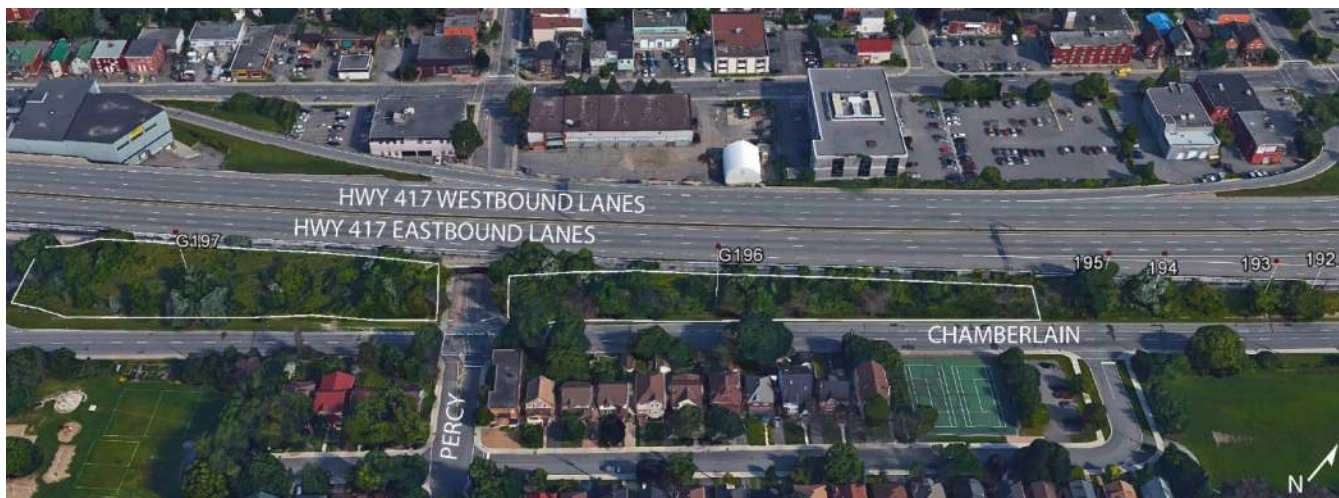
Figure 14: Tree Grouping 14 Mapping – Embankment on Chamberlain Ave.

G196	<i>Elaeagnus angustifolia</i>	Russian Olive	5	15-20		F	F	F	Vine in canopy, suppressed canopy growth (reduced CV)
G196	<i>Prunus sp.</i>	Cherry sp.	3	10-15		F	F	F	Vine in canopy, suppressed canopy growth (reduced CV)
G196	<i>Picea pungens</i>	Blue Spruce	3	15-25		F	F	F	Vine in canopy, suppressed canopy growth (reduced CV)
G196	<i>Ulmus pumila</i>	Siberian Elm	5	20-30		F	F	F	Vine in canopy, suppressed canopy growth (reduced CV)
G197	<i>Ulmus pumila</i>	Siberian Elm	7	15-25		F	F	F	-
G197	<i>Acer negundo</i>	Manitoba Maple	10	10-25		F	F	F	-
G197	<i>Acer platanoides</i>	Norway Maple	2	15-25		F	F	F	-
G197	<i>Elaeagnus angustifolia</i>	Russian Olive	5	10-20		F	F	F	-

TREE #	BOTANICAL NAME	COMMON NAME	NO.	DBH (CM)	HEIGHT (M)	CONDITION			
						TI	CS	CV	REMARKS
G197	<i>Ulmus americana</i>	American Elm	3	45-50		F	F	F	-
G197	<i>Picea pungens</i>	Blue Spruce	5	15-20		F	F	F	-

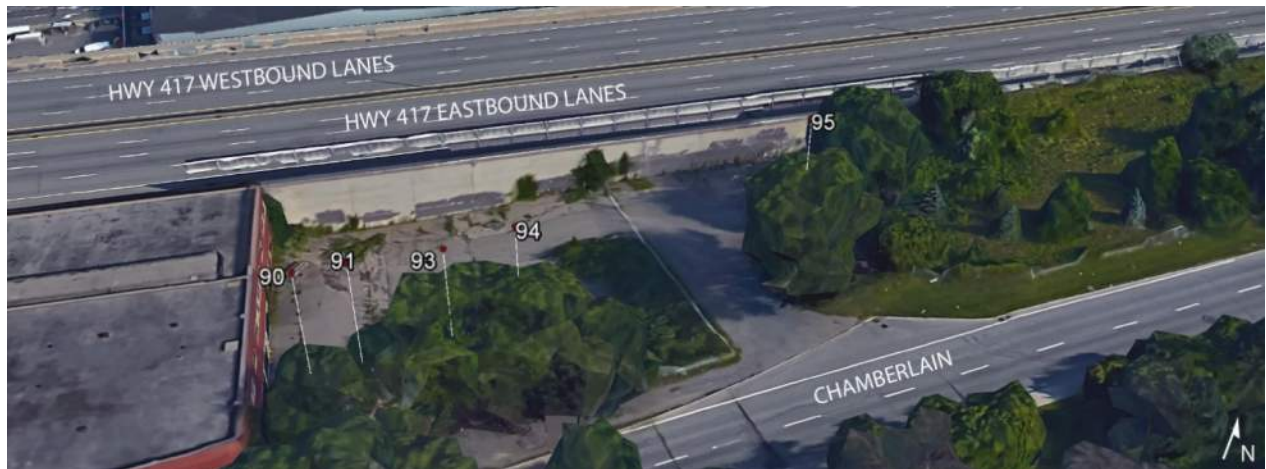
Figure 15: Tree Grouping 15 Mapping – Chamberlain Avenue between Bronson Avenue and Percy Street

TREE #	BOTANICAL NAME	COMMON NAME	NO.	DBH (CM)	HEIGHT (M)	CONDITION			
						TI	CS	CV	REMARKS
90	<i>Ulmus americana</i>	American Elm	1	25-35	-	F	F	F	Multi-stem (3). 8% deadwood.
91	<i>Ulmus americana</i>	American Elm	1	25-35	-	F	F	F	Mulit-stem (4). Suppressed canopy growth. Leaf insect damage.
92	<i>Ulmus americana</i>	American Elm	1	25-35	-	G	F	F	5 degree lean. 5% deadwood.
93	<i>Ulmus americana</i>	American Elm	1	25-35	-	P	P	F	Weak union. Suppressed canopy growth. 5% deadwood.

TREE #	BOTANICAL NAME	COMMON NAME	NO.	DBH (CM)	HEIGHT (M)	CONDITION			REMARKS
						TI	CS	CV	
94	<i>Ulmus americana</i>	American Elm	1	25-35	-	P	P	F	Granular fill at base.
95	<i>Ulmus americana</i>	American Elm	1	45-50	-	G	F	G	-

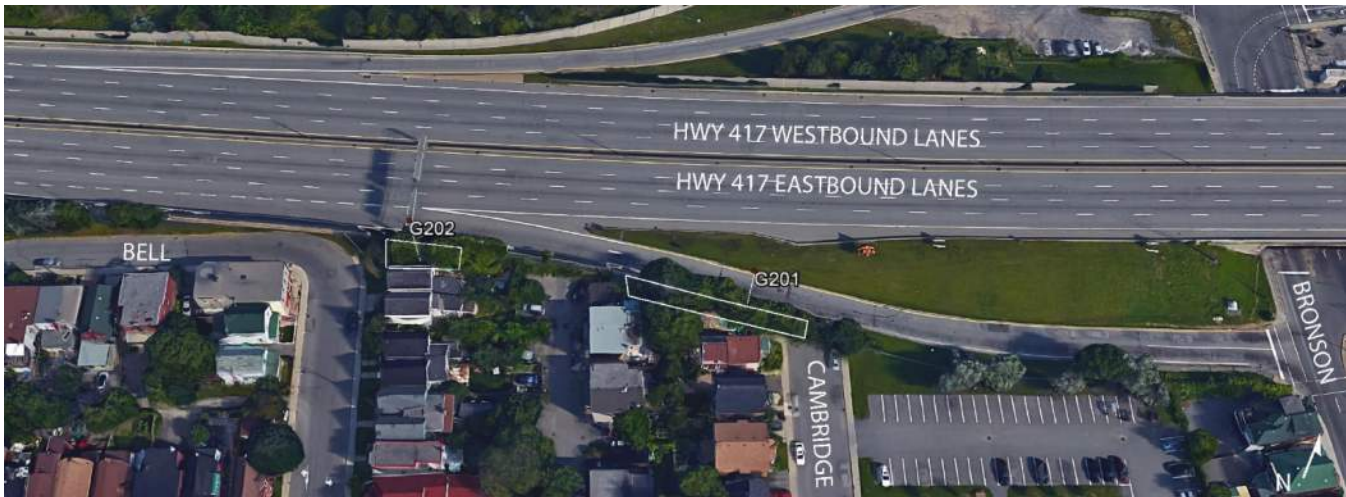
**Figure 16: Tree Grouping 16 Mapping – Embankment at Bronson Ave. Off-ramp**

TREE #	BOTANICAL NAME	COMMON NAME	NO.	DBH (CM)	HEIGHT (M)	CONDITION			REMARKS
						TI	CS	CV	
G201	<i>Acer negundo</i>	Manitoba Maple	11	15-20		F	F	F	Growing adjacent existing noise wall
G202	<i>Acer negundo</i>	Manitoba Maple	2	15-25		-	F	G	-

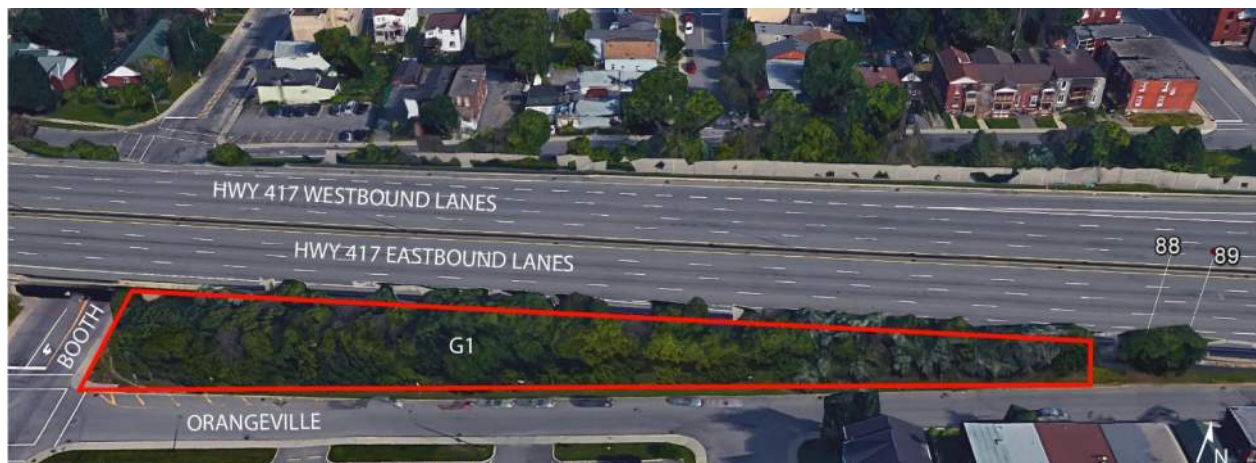
Figure 17: Tree Grouping 17 Mapping – Orangeville Street between Booth Street and Bell Street

TREE #	BOTANICAL NAME	COMMON NAME	NO.	DBH (CM)	HEIGHT (M)	CONDITION			
						TI	CS	CV	REMARKS
G1	<i>Acer negundo</i>	Manitoba Maple	~35	10-30	-	-	-	-	-
G1	<i>Ulmus americana</i>	American Elm	2	10-30	-	-	-	-	-
G1	<i>Elaeagnus angustifolia</i>	Russian Olive	~11	10-30	-	-	-	-	-
G1	<i>Acer platanoides</i>	Norway Maple	~6	10-30	-	-	-	-	-
G1	<i>Pinus resinosa</i>	Red Pine	~8	10-30	-	-	-	-	-
G1	<i>Celtis occidentalis</i>	Hackberry	~4	10-30	-	-	-	-	-
88	<i>Celtis occidentalis</i>	Hackberry	1	15	-	P	P	P	-

TREE #	BOTANICAL NAME	COMMON NAME	NO.	DBH (CM)	HEIGHT (M)	CONDITION			REMARKS
						TI	CS	CV	
89	<i>Celtis occidentalis</i>	Hackberry	1	15	-	P	P	P	-

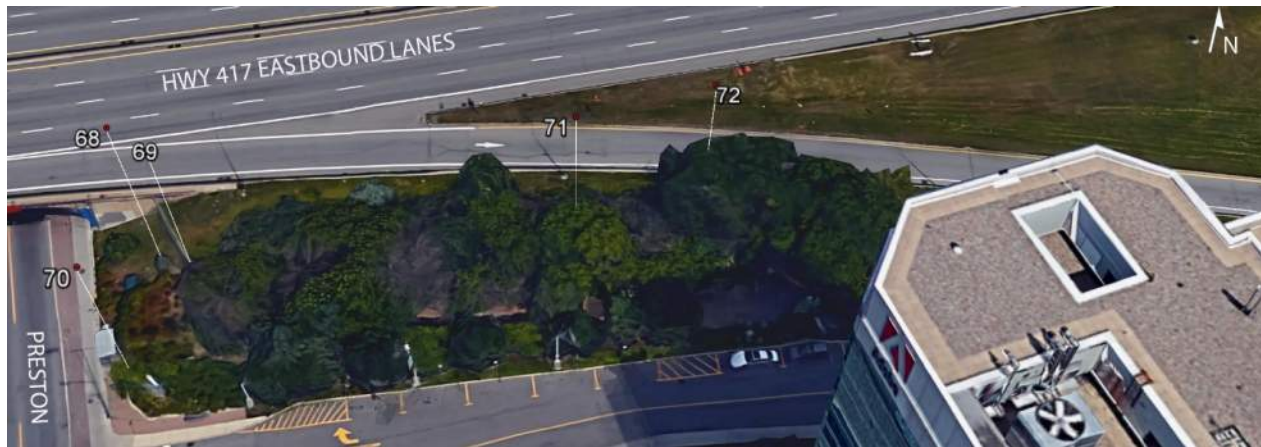
**Figure 19: Tree Grouping 19 Mapping– Rochester Street Highway off-ramp at Preston Street**

TREE #	BOTANICAL NAME	COMMON NAME	NO.	DBH (CM)	HEIGHT (M)	CONDITION			REMARKS
						TI	CS	CV	
68	<i>Picea pungens</i>	Blue Spruce	1	10	4	G	G	G	On City of Ottawa R.O.W.
69	<i>Picea glauca</i>	White Spruce	1	10	4	G	G	G	On City of Ottawa R.O.W.
70	<i>Gleditsia triacanthos</i>	Honey Locust	1	10	5	G	G	G	On City of Ottawa R.O.W.
71	<i>Celtis occidentalis</i>	Hackberry	1	15-20	10	F	F	F	-
72	<i>Acer negundo</i>	Manitoba Maple	4	15-25	10	F	F	F	Grouping of multi-stems.

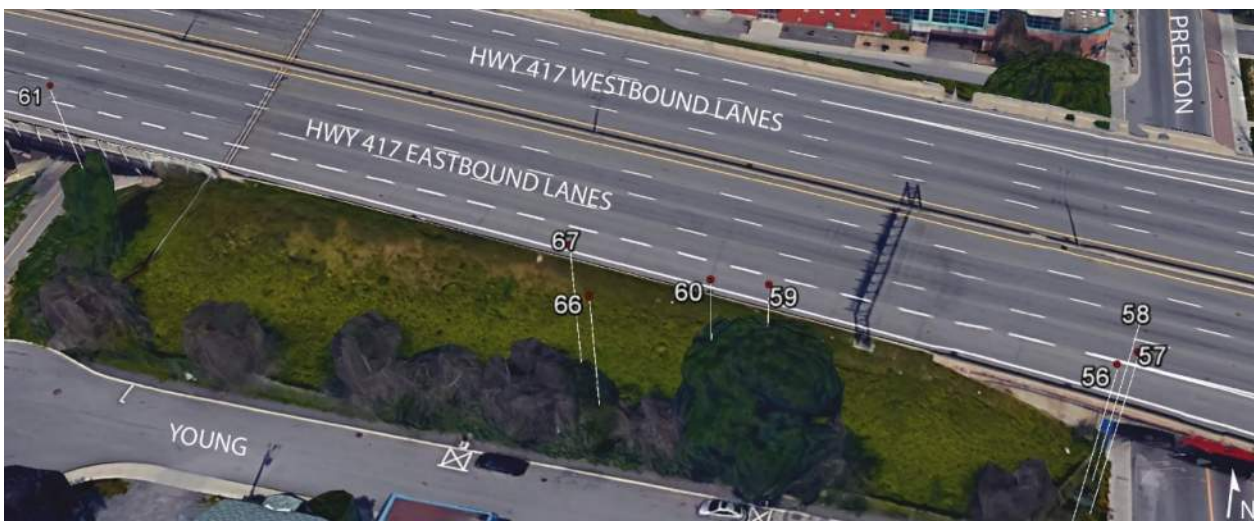
**Figure 20: Tree Grouping 20 Mapping – Young Street at Preston Street**

TREE #	BOTANICAL NAME	COMMON NAME	NO.	DBH (CM)	HEIGHT (M)	CONDITION			REMARKS
						TI	CS	CV	
56	<i>Picea glauca</i>	White Spruce	1	10	4	G	G	G	On City of Ottawa R.O.W.
57	<i>Picea pungens</i>	Blue Spruce	1	10	4	G	G	G	On City of Ottawa R.O.W.
58	<i>Picea glauca</i>	White Spruce	1	10	4	G	G	F	On City of Ottawa R.O.W.
59	<i>Ulmus americana</i>	American Elm	1	30-40	20	G	F	F	5% deadwood. Internal bunching. Insect damaged leaves.
60	<i>Ulmus americana</i>	American Elm	1	50-60	20	F	G	F	5% deadwood. Internal bunching. Insect damaged leaves.
61	<i>Ulmus americana</i>	American Elm	1	30	15	F	G	F	Suckering at base. Insect damaged on leaves.
62-65 – Refer to Table 7: Tree Grouping 7 Inventory – St. Anthony Street at Preston Street									
66	<i>Acer negundo</i>	Manitoba Maple	1	15-20	10	P	P	F	Growing on fence line.
67	<i>Acer platanoides</i>	Norway Maple	1	15-20	8	F	F	F	Multi-stem. Suppressed canopy growth,

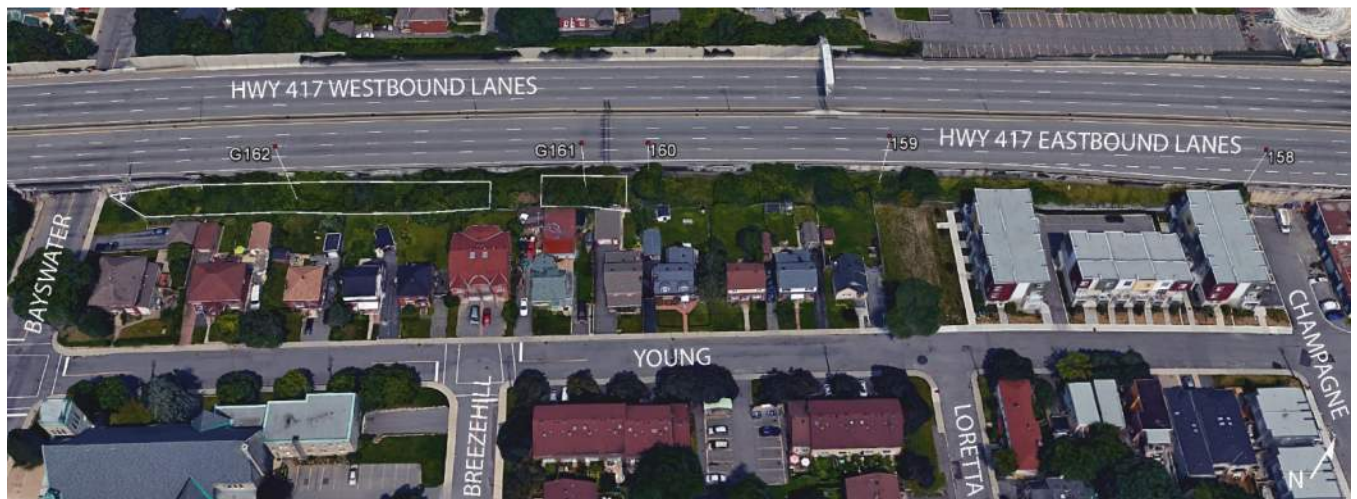
**Figure 21: Tree Grouping 21 Mapping – Embankment on Young St.: Champagne Ave. to Bayswater Ave.**

TREE #	BOTANICAL NAME	COMMON NAME	NO.	DBH (CM)	HEIGHT (M)	CONDITION			REMARKS
						TI	CS	CV	
158	<i>Ulmus pumila</i>	Siberian Elm	1	~16		F	F	F	Suppressed canopy growth (70%CV)
159	<i>Acer ginnala</i>	Amur maple	1	-		P	P	P	Multiple stems (2), weak union, suppressed canopy growth (70%CV)
160	<i>Acer negundo</i>	Manitoba Maple	1	20-25		-	F	F	-
G161	<i>Acer negundo</i>	Manitoba Maple	5	15-20		P	F	P	Poor condition
G162	<i>Acer negundo</i>	Manitoba Maple	2	15-20		F	F	F	-

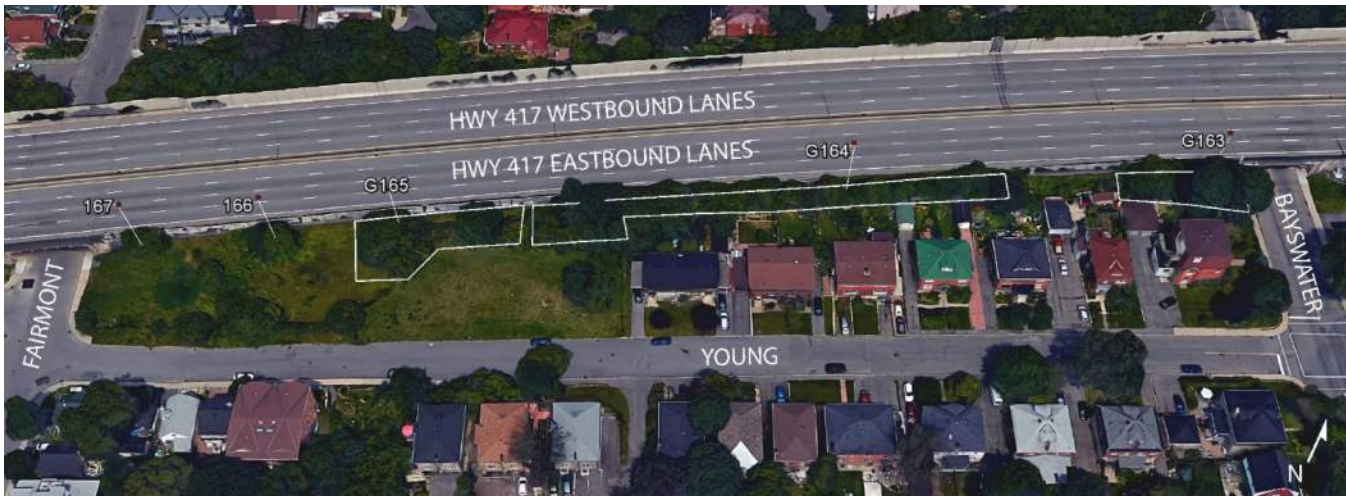
**Figure 22: Tree Grouping 22 Mapping – Embankment on Young St.: Bayswater Ave. to Fairmont Ave.**

TREE #	BOTANICAL NAME	COMMON NAME	NO.	DBH (CM)	HEIGHT (M)	CONDITION			REMARKS
						TI	CS	CV	
G163	<i>Acer negundo</i>	Manitoba Maple	3	-		F	F	F	-
G164	<i>Acer platanoides</i>	Norway Maple	2	15-20		-	G	G	-
G164	<i>Acer negundo</i>	Manitoba Maple	16	10-25		-	G	G	-
G165	<i>Acer negundo</i>	Manitoba Maple	3	15-20		F	F	G	-
166	<i>Acer negundo</i>	Manitoba Maple	1	15-20		F	G	G	-
167	<i>Acer negundo</i>	Manitoba Maple	1	10-15		F	F	P	-

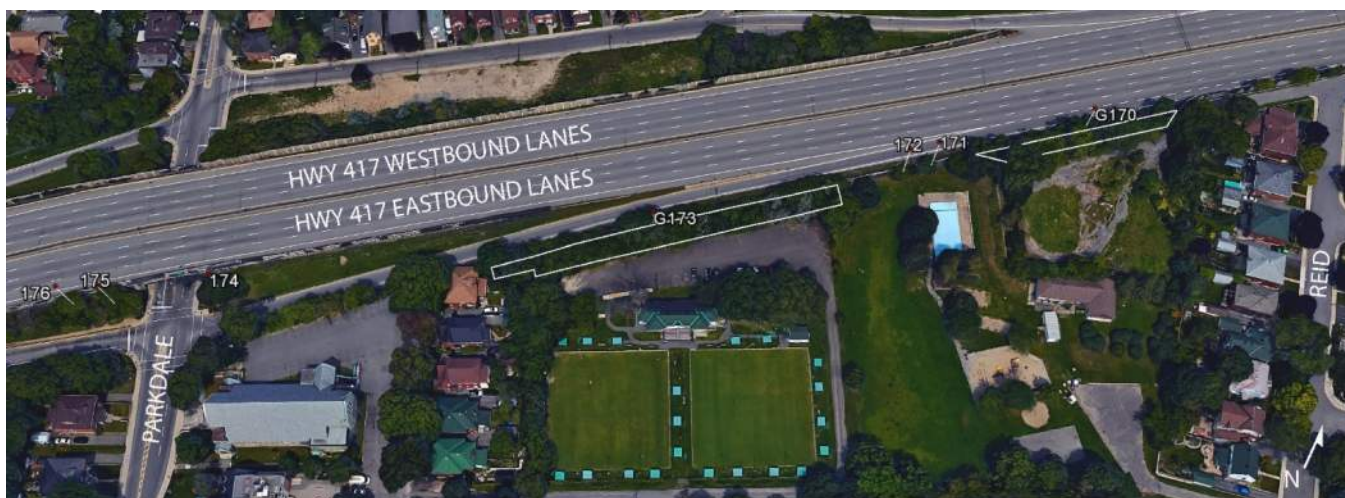
**Figure 24: Tree Grouping 24 Mapping – Embankment on Eastbound Parkdale HWY On-ramp**

TREE #	BOTANICAL NAME	COMMON NAME	NO.	DBH (CM)	HEIGHT (M)	CONDITION			REMARKS
						TI	CS	CV	
G170	<i>Acer negundo</i>	Manitoba Maple	16	10-25		F	F	P	Suppressed canopy growth (60-80%CV)
G170	<i>Acer platanoides</i>	Norway Maple	9	10-20		F	F	F	Suppressed canopy growth (60-80%CV)
G170	<i>Ulmus pumila</i>	Siberian Elm	3	20-25		F	F	P	Suppressed canopy growth (60-80%CV)
171	<i>Malus sp.</i>	Apple sp.	1	15-20		F	F	G	Multiple stems
172	<i>Malus sp.</i>	Apple sp.	1	14		F	F	F	Weak union
G173	<i>Acer negundo</i>	Manitoba Maple	29	20-35		F	F	F	-
G173	<i>Ulmus pumila</i>	Siberian Elm	3	25-30		F	F	F	Suppressed canopy growth (70-80%CV)
G173	<i>Elaeagnus angustifolia</i>	Russian Olive	3	20-25		F	F	F	Suppressed canopy growth (70-80%CV)
G173	<i>Acer ginnala</i>	Amur maple	9	10-15		G	F	F	Suppressed canopy growth (70-80%CV), multiple stems, weak unions
G173	<i>Acer platanoides</i>	Norway Maple	2	15-20		G	G	G	-
174	<i>Acer platanoides</i>	Norway Maple	1	~25		F	F	G	-

175	<i>Acer negundo</i>	Manitoba Maple	1	~15		P	F	F	Weak unions, multiple stems
176	<i>Acer negundo</i>	Manitoba Maple	1	~12		P	F	F	Weak unions, multiple stems

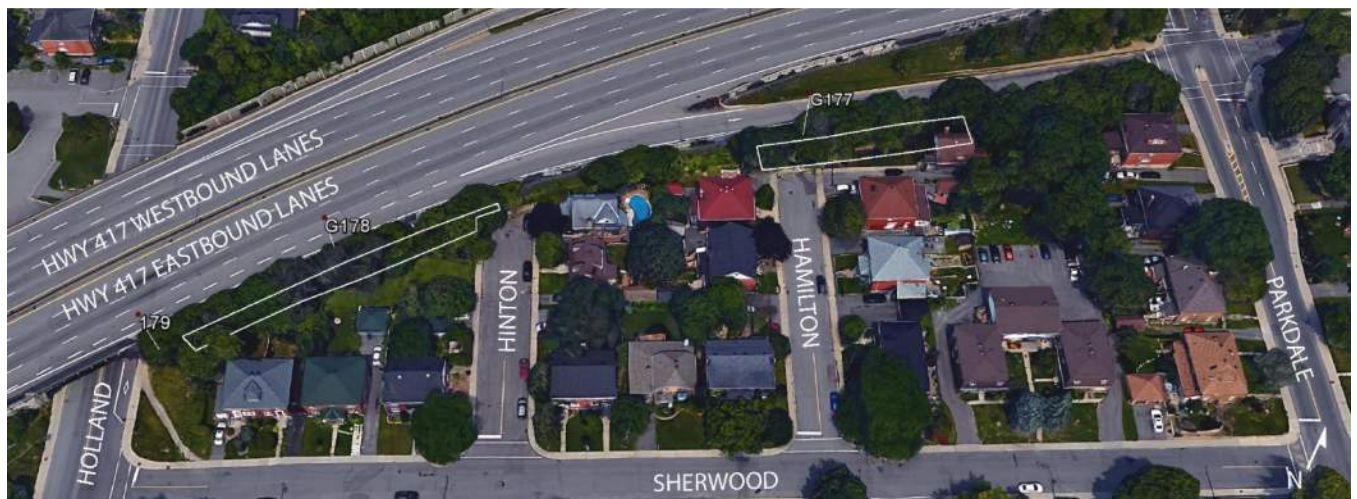
**Figure 25: Tree Grouping 25 Mapping – Embankment on Eastbound Parkdale HWY Off-ramp**

TREE #	BOTANICAL NAME	COMMON NAME	NO.	DBH (CM)	HEIGHT (M)	CONDITION			REMARKS
						TI	CS	CV	
G177	<i>Acer negundo</i>	Manitoba Maple	9	20-25		F	F	F	Weak unions, multiple stems
G178	<i>Acer negundo</i>	Manitoba Maple	5	15-25		F	F	F	Weak unions, multiple stems
G179	<i>Acer negundo</i>	Manitoba Maple	7	20-25		F	F	F	Weak unions, multiple stems

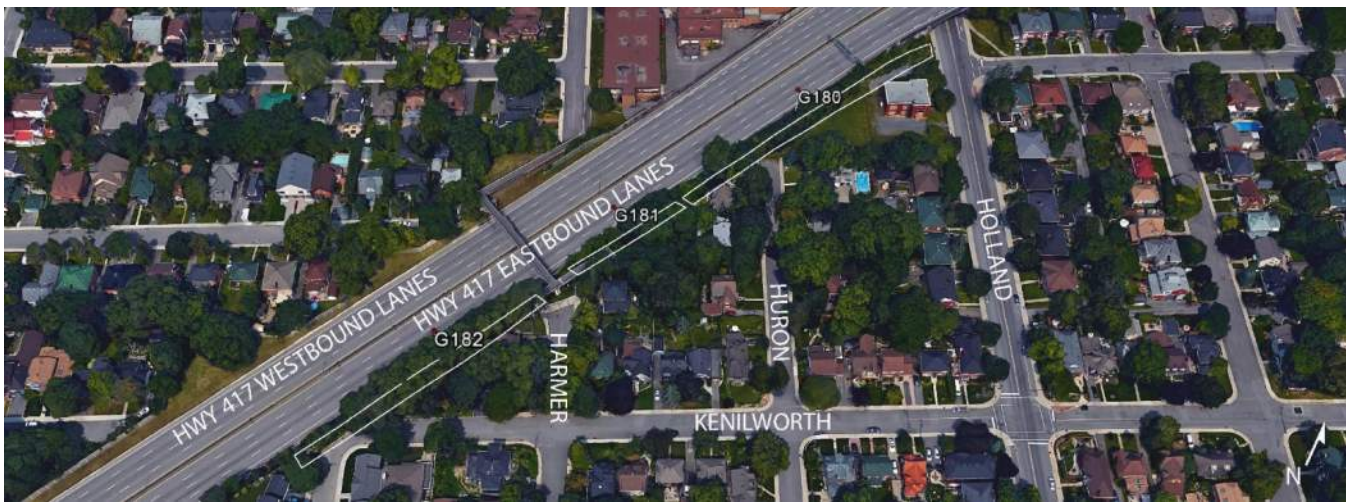
**Figure 26: Tree Grouping 26 Mapping – Embankment: Holland Ave. to Fairfax Ave.**

TREE #	BOTANICAL NAME	COMMON NAME	NO.	DBH (CM)	HEIGHT (M)	CONDITION			REMARKS
						TI	CS	CV	
G180	<i>Acer ginnala</i>	Amur maple	6	10-15		F	F	F	Suppressed canopy growth
G180	<i>Prunus sp.</i>	Cherry sp.	3	10-20		P	F	F	Suppressed canopy growth
G180	<i>Acer platanoides</i>	Norway Maple	8	20-25		F	F	F	Suppressed canopy growth
G180	<i>Ulmus pumila</i>	Siberian Elm	3	20-25		F	F	F	Suppressed canopy growth
G180	<i>Acer negundo</i>	Manitoba Maple	10	20-30		F	F	F	Suppressed canopy growth
G180	<i>Populus tremuloides</i>	Trembling Aspen	1	~45		F	F	F	Suppressed canopy growth
G181	<i>Ulmus pumila</i>	Siberian Elm	12	10-15		F	F	F	Adjacent existing noise wall, limb/prune as required
G182	<i>Ulmus pumila</i>	Siberian Elm	19	25-45		G	G	F	Adjacent existing noise wall, limb/prune as required
G182	<i>Acer platanoides</i>	Norway Maple	6	20-25		F	F	F	-

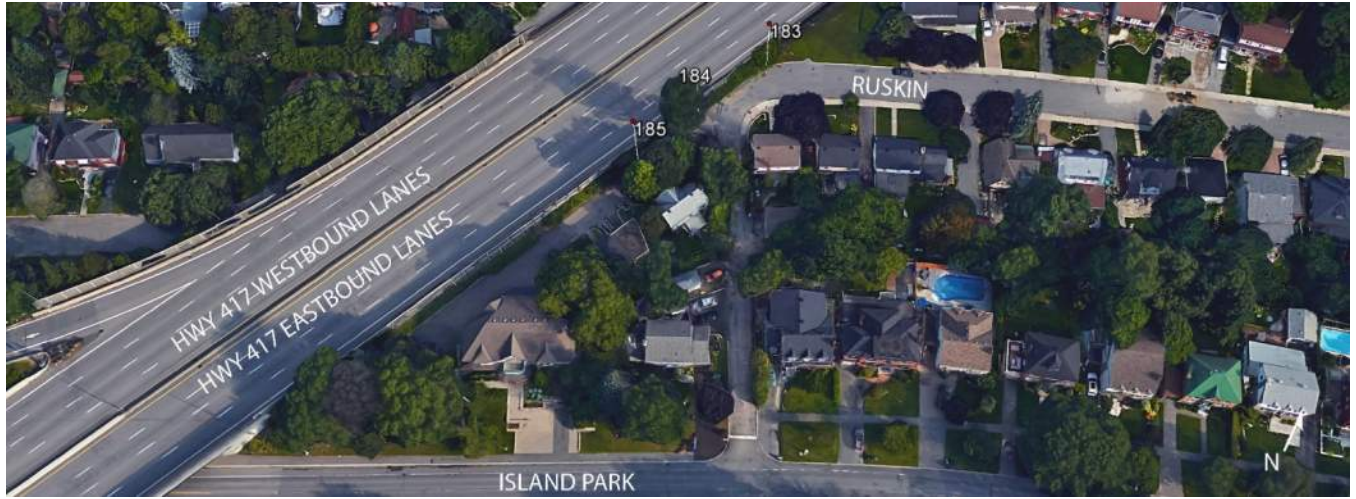
**Figure 27: Tree Grouping 27 Inventory – Boulevard on Ruskin St.**

TREE #	BOTANICAL NAME	COMMON NAME	NO.	DBH (CM)	HEIGHT (M)	CONDITION			
						TI	CS	CV	REMARKS
183	<i>Acer negundo</i>	Manitoba Maple	1	15		P	P	F	-
184	<i>Ulmus pumila</i>	Siberian Elm	1	52		G	F	F	10% deadwood, large tree
185	<i>Acer platanoides</i>	Norway Maple	1	13		P	F	P	Suppressed canopy growth (50%CV)

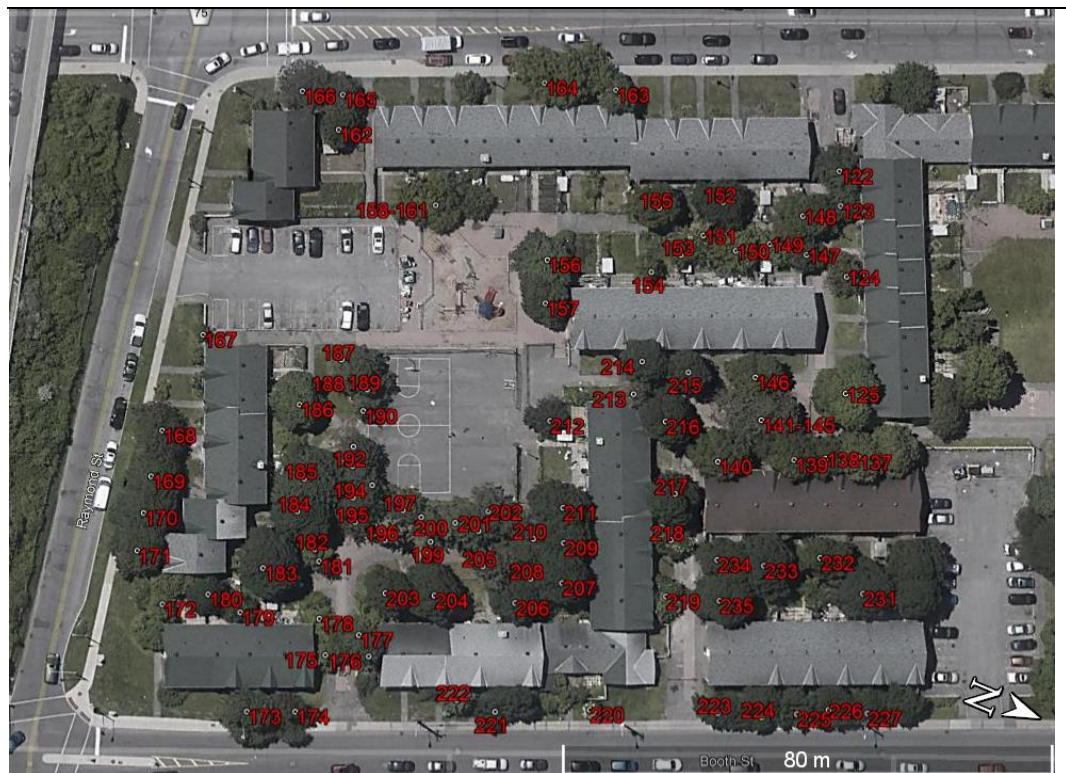
## TREE INVENTORY MAP

The following table and map represent an updated tree assessment as completed by WSP in June 2020. The inventory table below only includes trees within the staging area and adjacent City ROW. The tree ID numbers have been maintained consistent with the previously submitted Tree Conservation Report (GHD). Most of the remaining trees are unchanged in size and condition since July 2019. However, seventeen (17) trees have either died or been removed since that time.

Also, additional trunk and canopy damage was noted. This can likely be attributed to the demolition and removal of the residential units.
