HIGHWAY 417 (OTTAWA QUEENSWAY) BRIDGE REPLACEMENT/REHABILITATION AND OPERATIONAL IMPROVEMENTS

DESIGNATED SUBSTANCES SURVEY

ONTARIO MINISTRY OF TRANSPORTATION

PROJECT NO.: G.W.P.4145-10-00
DATE: NOVEMBER 2018

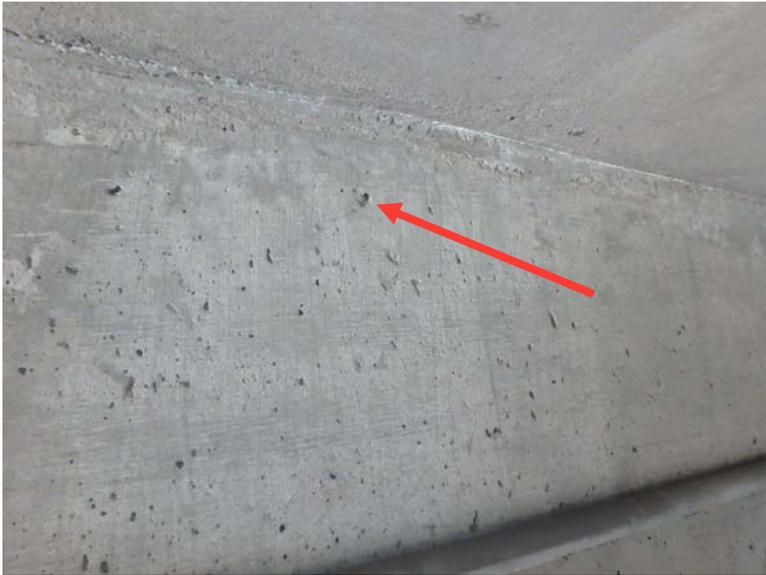
<p>7</p>	<p><u>Asbestos Containing Textured Coated Wall Covering</u></p> <p>observed on abutment walls throughout the subject area.</p> <p>Sample ID: PRCY-CON-2G</p>
